Immediate implant placement with simultaneous ridge augmentation

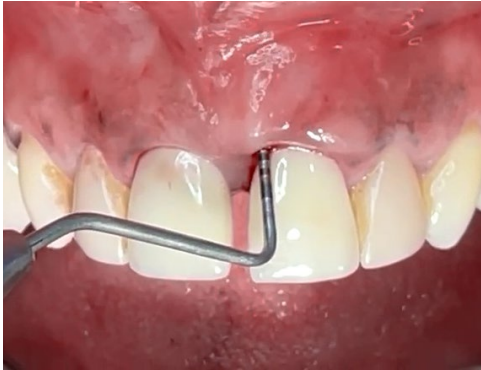
A periodontal probe easily enters the gum due to lack of bone underneath.

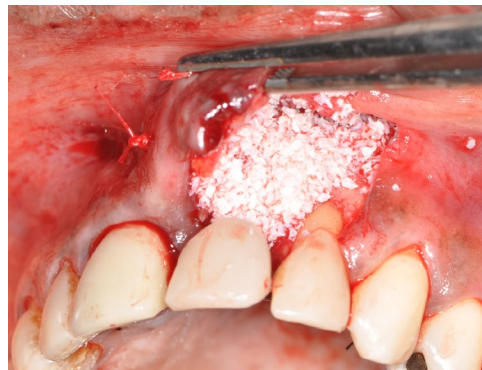
InterOss® placement.

An implant was placed immediately in the cavity which, along with the wall defect, was then filled with InterOss® and covered with a collagen membrane and a connective tissue graft on top. Post-operative X-ray at 8 months shows a new buccal wall securely holding the implant in place.

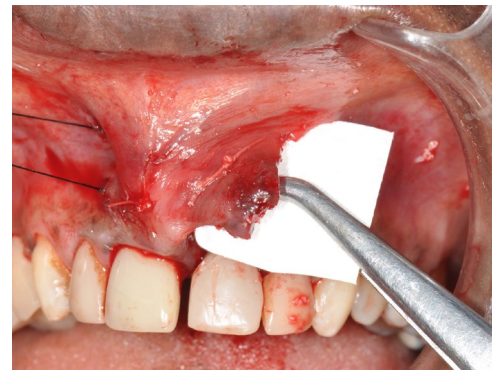
Collagen membrane placement.
