Guided bone regeneration of a horizontal-vertical deficiency

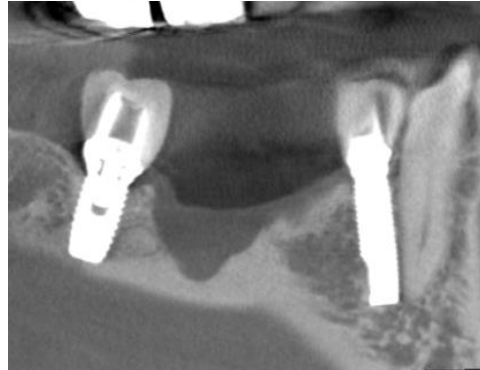
Pre-operative CBCT scan shows the cavity left by the extracted tooth.

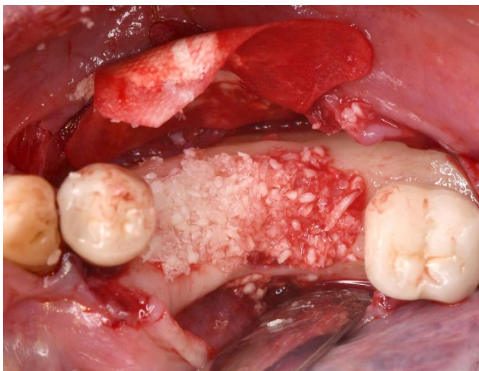
Placement of the InterOss® and bone chips mixture.

After a degranulation, the socket was then filled with InterOss® mixed with allograft and autogenous bone. No complications were recorded during the follow-up. At re-entry, the grafted bone has been perfectly integrated with the native bone, enabling the installation of two implants.

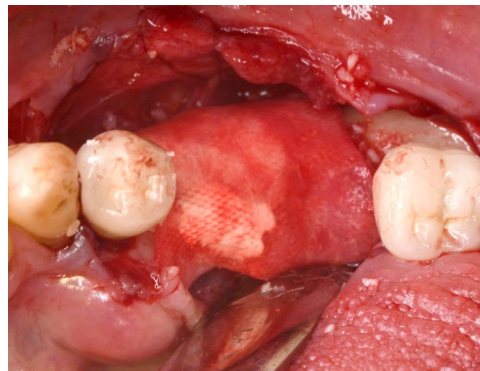
Collagen membrane placement.

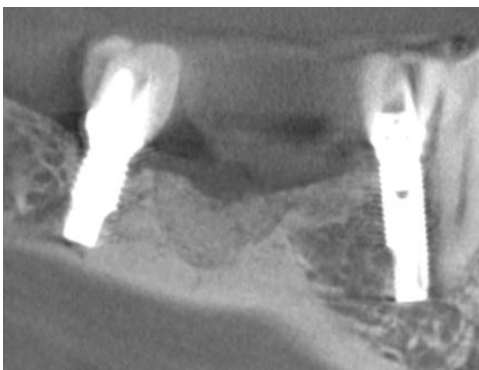
Post-operative CBCT scan at 4 months.

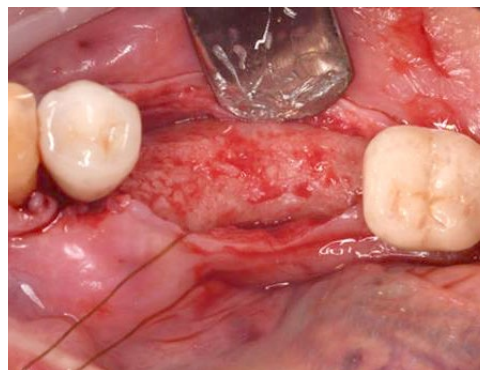
Re-entry at 6 months shows new bone formation.

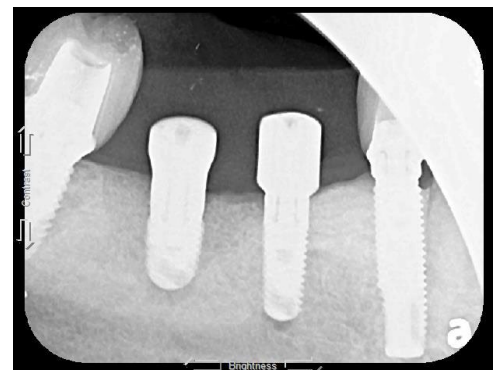
Post-loading X-ray shows the new bone holding the implants properly in place.

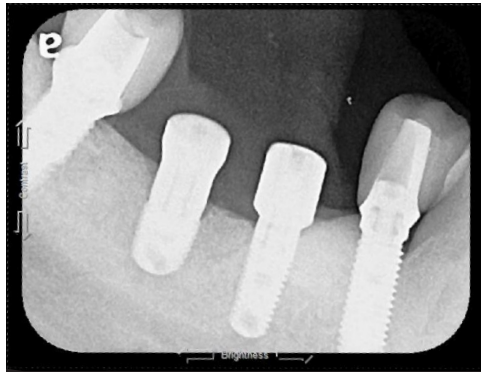
Post-loading X-ray at 3 months.
