# Lateral window sinus floor elevation with simultaneous implant placement

## Patient History

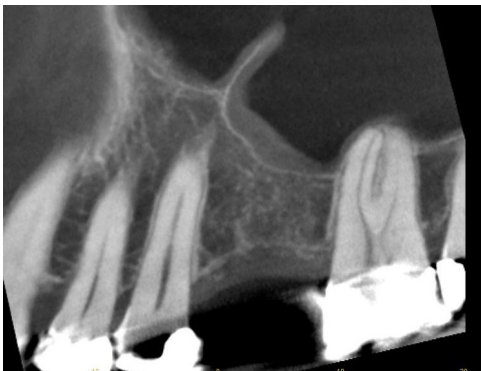
Pre-operative CBCT scan shows the extent of the pneumatized sinus.

Patient had a missing tooth, and the immediate bone area has undergone a resorption, expanding the sinus cavity. The condition was to be treated with an implant and a sinus lift to achieve enough bone mass to hold the device.

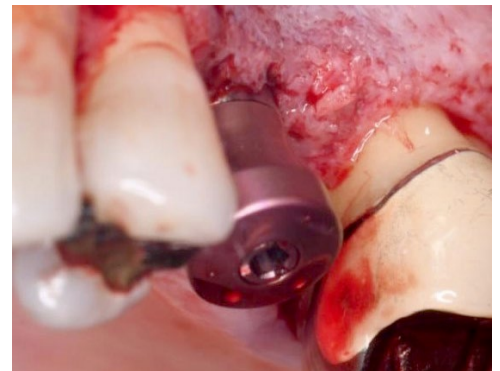
Implant placement.

With the lateral window carved, an implant was placed immediately and the cavity, preventively lined with a collagen membrane, filled with InterOss®. No adverse events were recorded during healing, and the granules did not perforate the sinus membrane.

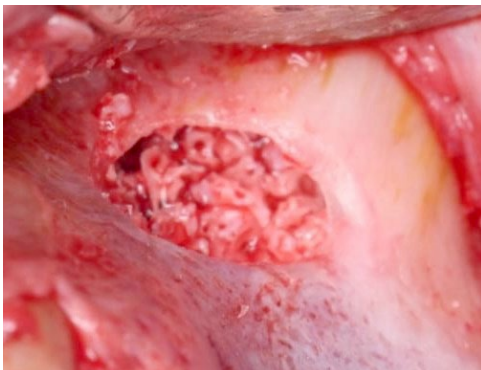
InterOss® placement.

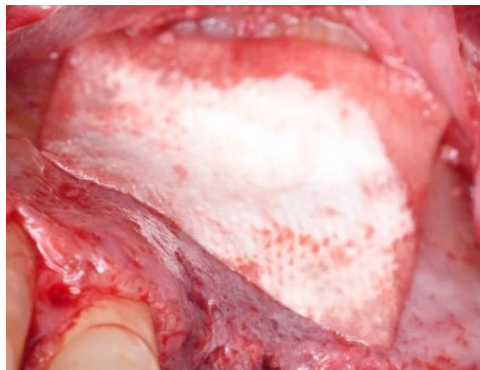
Collagen membrane placement.

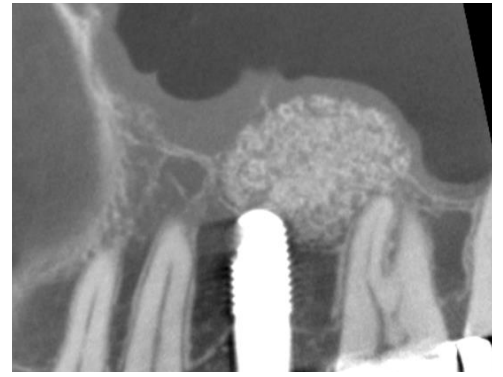
And the CBCT scan shows the grafted bone lifting the sinus floor, making space for the implant.
