Implant placement and simultaneous guided bone regeneration

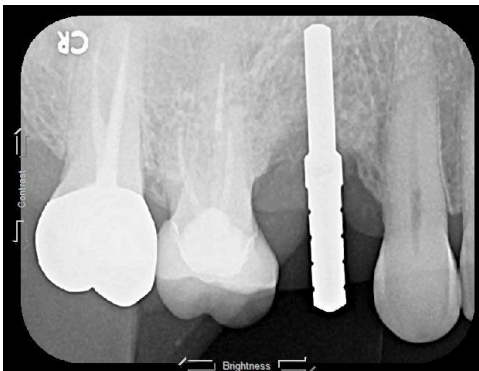
Intra-osteotomy X-ray shows the positioning of the drill bit.

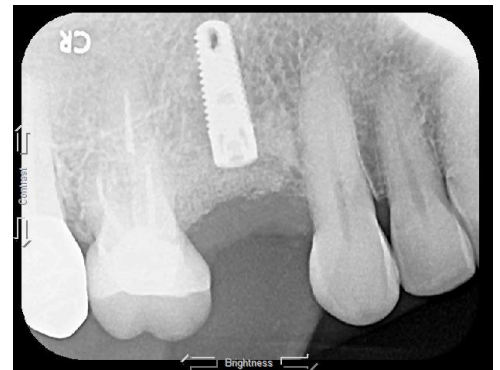
Immediate post-operative CBCT scan.
