# Alveolar ridge augmentation due to peri-implantitis

## Patient History

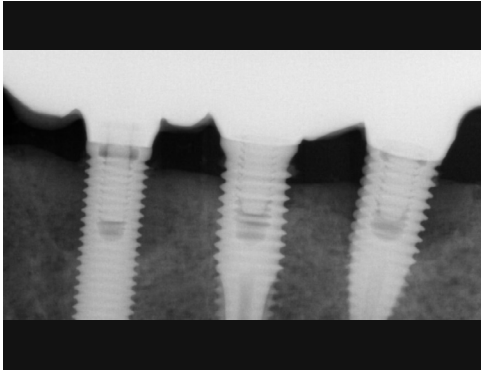
Pre-operative X-ray shows bone loss around multiple implants.

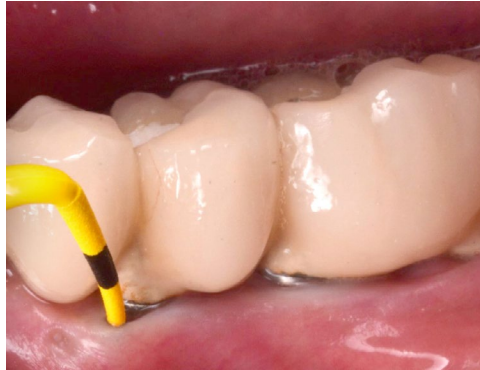
A periodontal probe easily enters the gum due to lack of bone underneath.

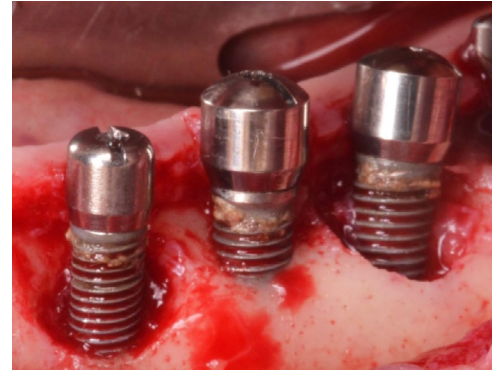
A view of the bone defect.

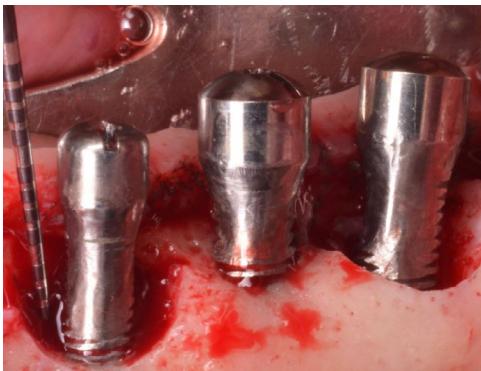
Post-implantoplasty view.

After an implantoplasty was performed, the receding bone around the implant was filled with a mixture of InterOss® and autogenous bone. X-ray at 12 months shows new bone now surrounding the implant.

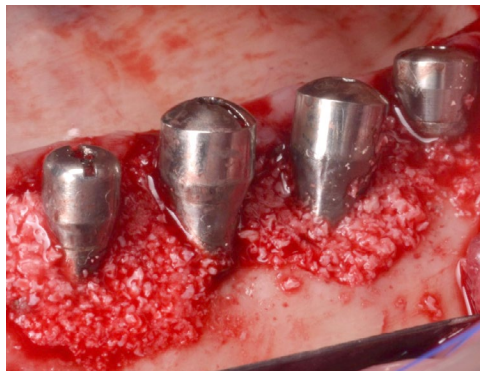
Placement of the InterOss® and autogenous bone mixture.

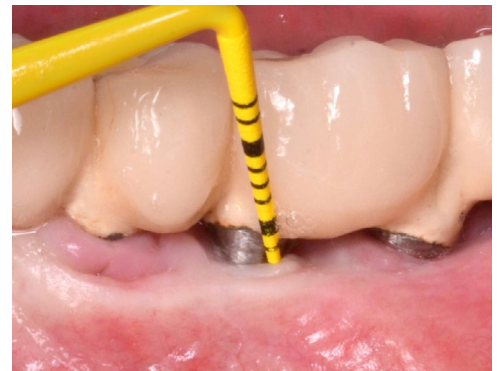
12 months after, there was now solid bone underneath the gum.

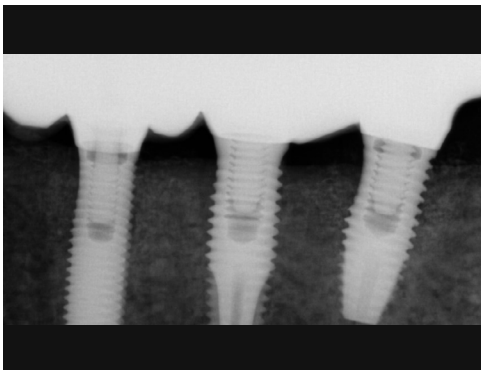
Post-operative X-ray at 12 months shows there were no more gaps.
