Immediate implant placement with simultaneous ridge augmentation

Patient History

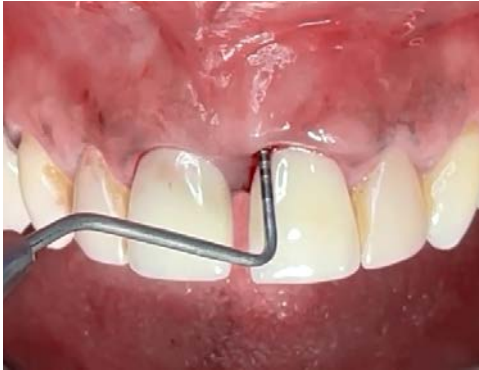
A periodontal probe shows the depth of the defect.

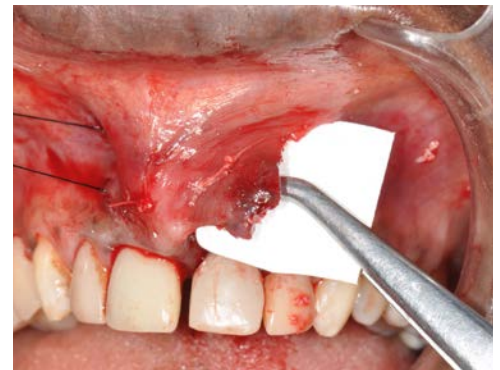
Collagen membrane placement.
