# Immediate implant placement with simultaneous guided bone regeneration

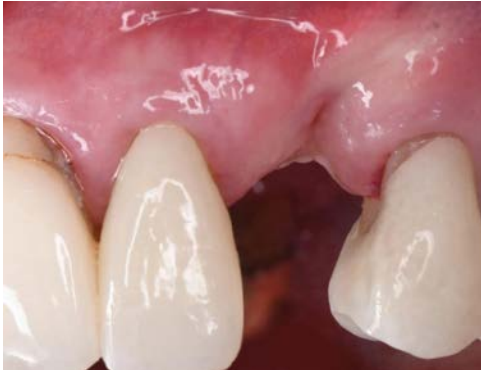
Pre-operative view.

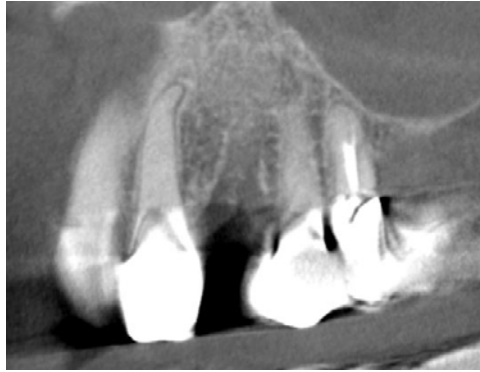
Pre-operative CBCT scan.

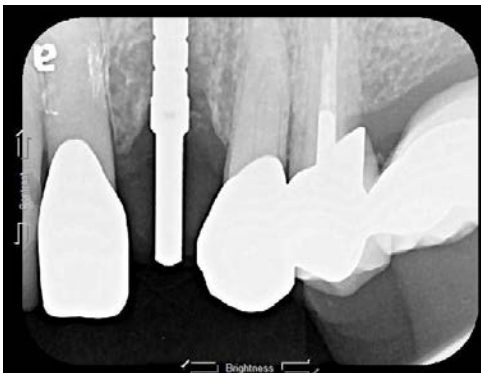
Intra-osteotomy X-ray.

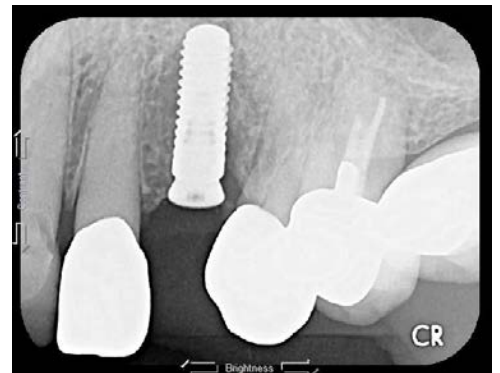
Post-loading X-ray.

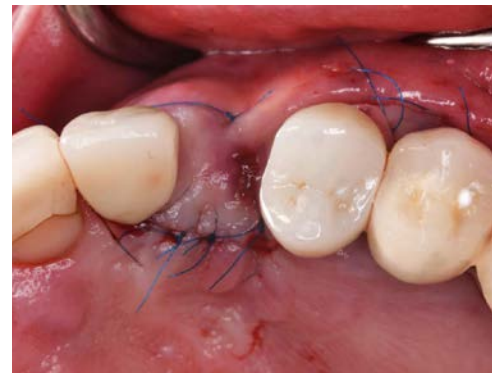
Post-surgical view.

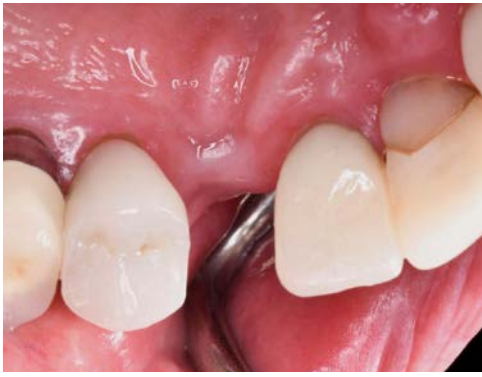
Post-operative view at 6 weeks.

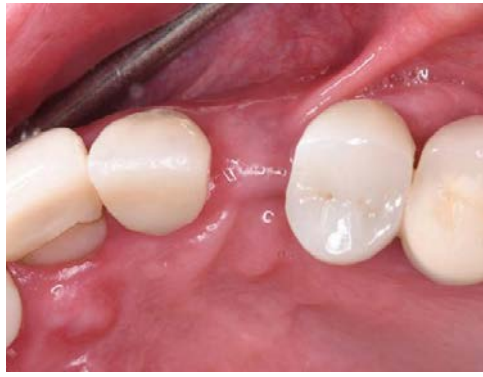
Post-operative view at 5 months.

An implant was placed immediately in the cavity which, along with the facial gap, was then filled with InterOss®. Follow-up at 5 months revealed new bone with good space maintenance properties and no noted recession or ridge collapse during healing.
