# Lateral window sinus floor elevation with simultaneous implant placement

## Patient History

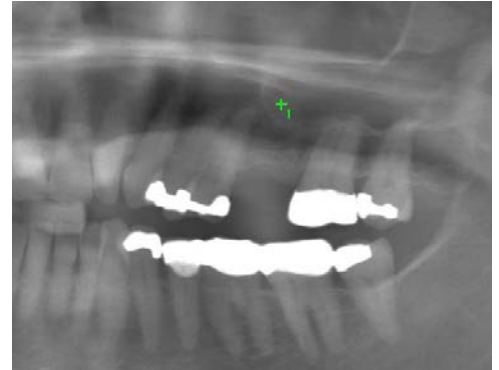
Pre-operative X-ray.

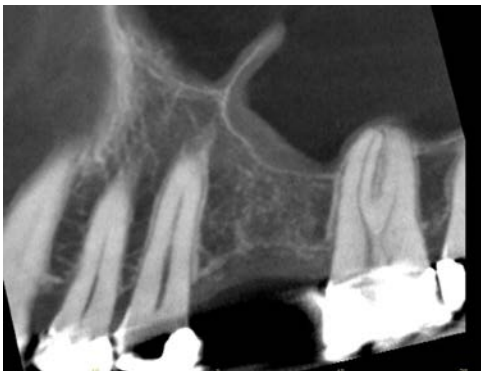
Pre-operative CBCT scan.

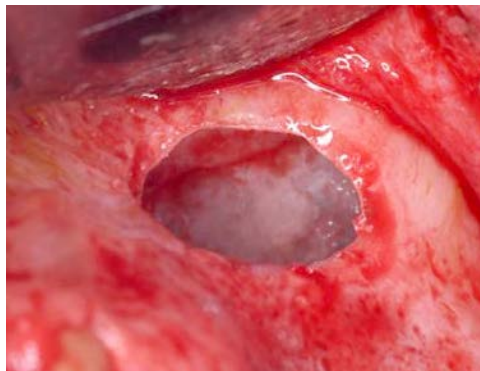
A view of the lateral window.

With the lateral window carved, an implant was placed immediately and the cavity, preventively lined with a collagen membrane, filled with InterOss®. No adverse events were recorded during healing, and the granules did not perforate the sinus membrane.

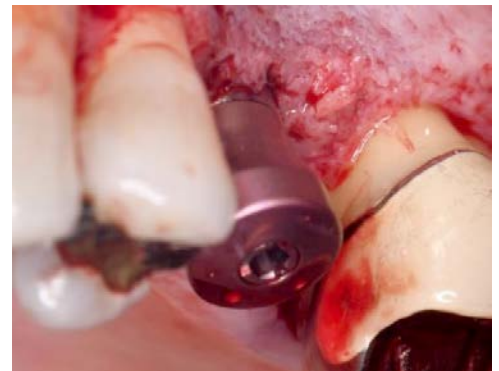
Implant placement.

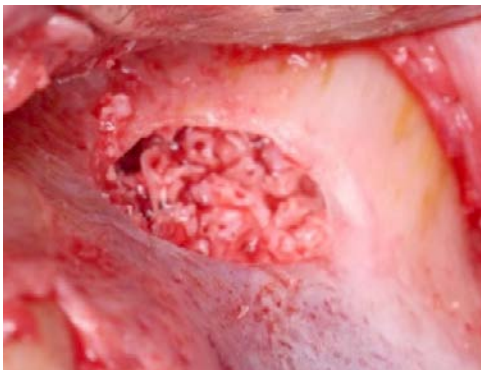
InterOss® placement.

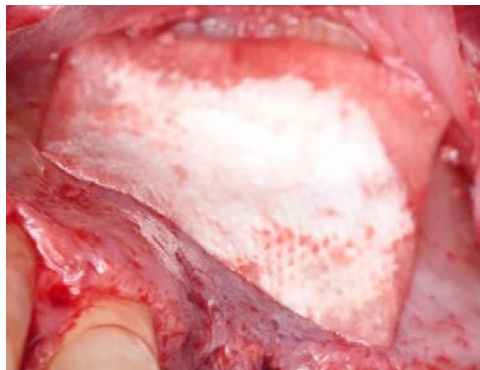
Collagen membrane placement.

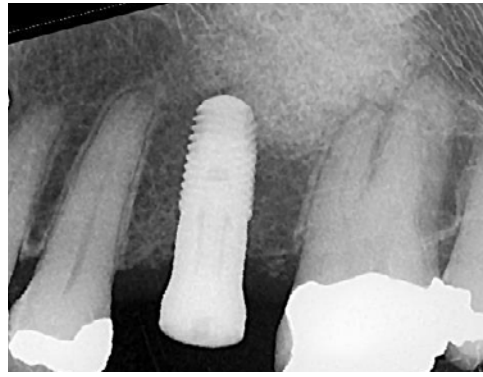
Post-operative X-ray at 4 months..

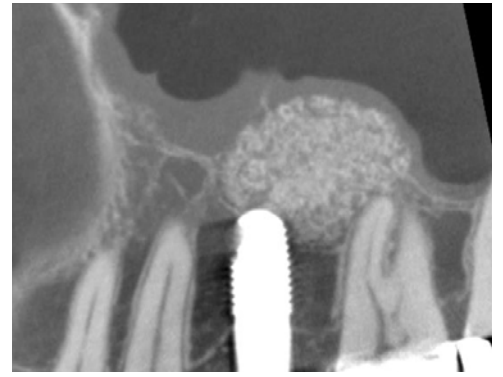
Post-operative CBCT scan at 4 months.
