Implant placement and simultaneous guided bone regeneration

Patient History

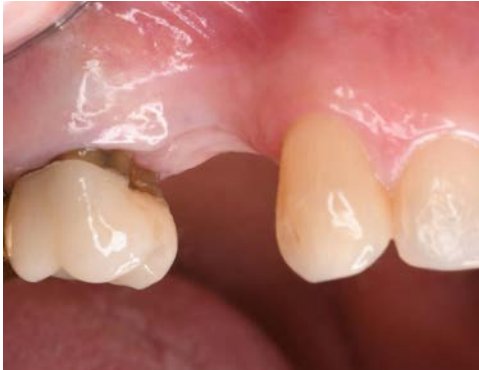
Pre-operative view.

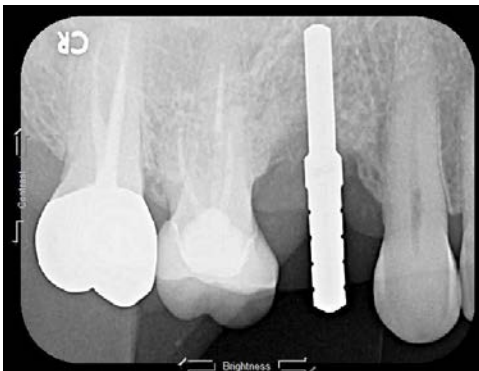
Intra-osteotomy X-ray.

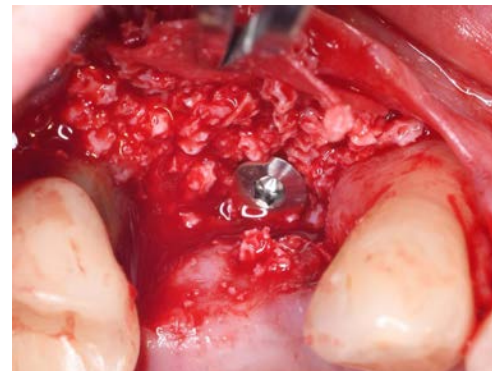
InterOss® placement.

Implant was placed 2 mm supracrestally and InterOss® was used to graft the infrabony and suprabony component of the defect. No adverse events were recorded during healing, and after 3 months, the volume of the ridge was perfectly maintained as can be seen in the X-ray.

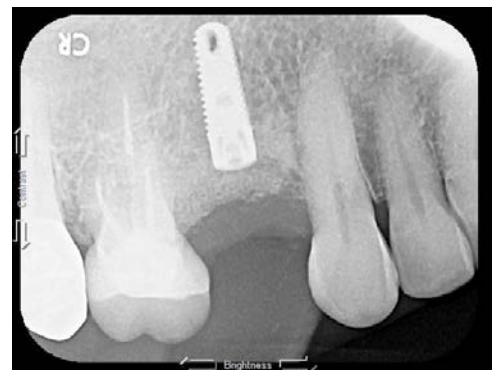
Post-surgical CBCT scan.

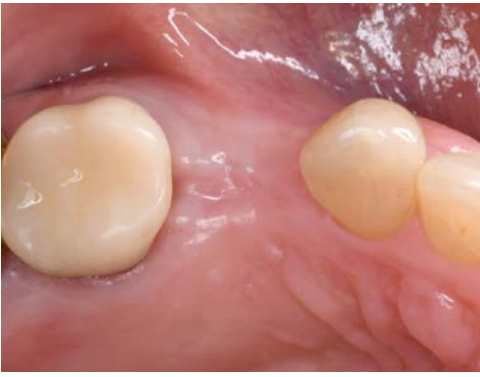
Post-operative view at 3 months.

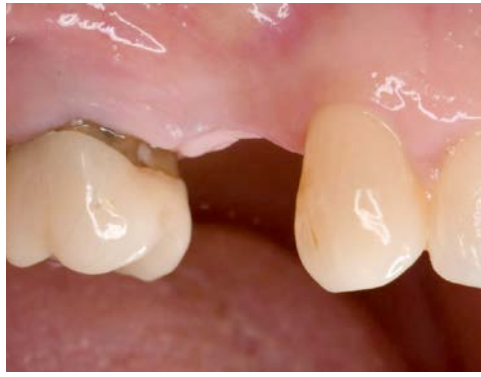
Another post-operative view at 3 months.

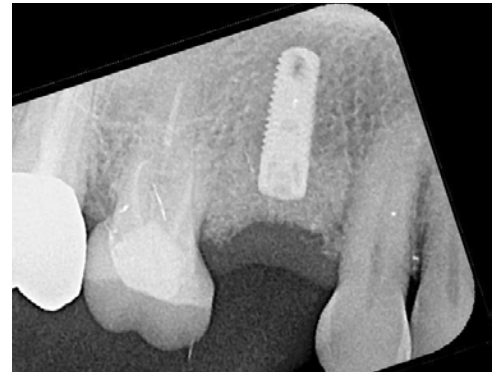
Post-operative X-ray at 3 months.
