Staged guided bone regeneration and implant placement in anterior maxilla

Patient History

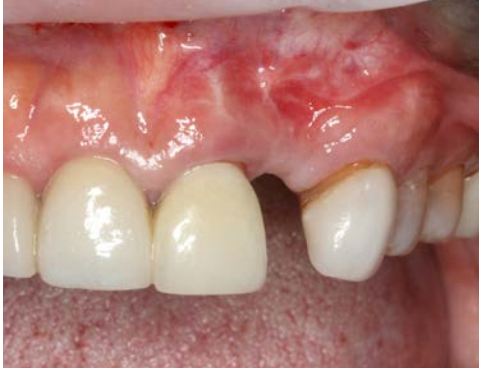
Pre-operative view.

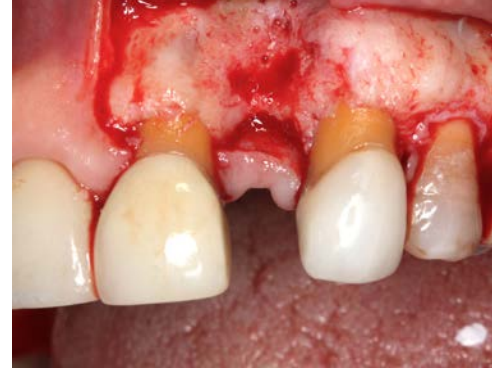
A view of the bone defect.

Patient is missing tooth #10, and its absence has caused resorption to the affected bone. The condition was to be treated with an implant and bone grafting to gain back the space needed for the device.

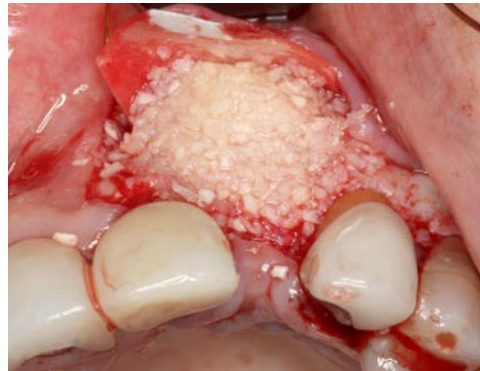
InterOss® and SigmaOss™ placement.

InterOss® and SigmaOss® were placed in the defect's gap which were then wrapped with a collagen membrane. After 9 months, newly formed bone with a significant thickness can be observed.

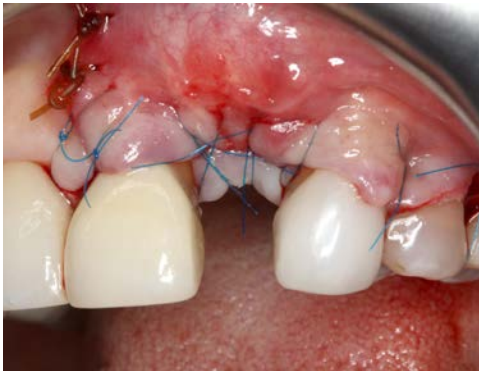
Post-surgical view.

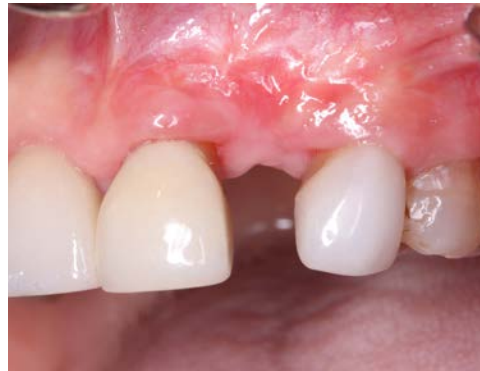
Post-grafting view at 9 months.

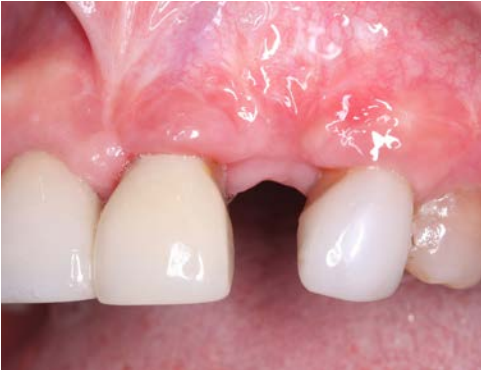
Post-implant follow-up view at 2 months.
