# Alveolar ridge augmentation due to peri-implantitis

## Patient History

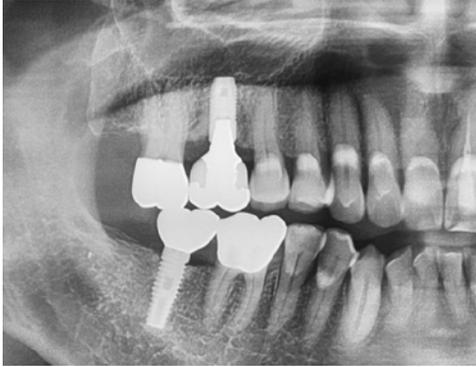
X-ray taken 8 years prior shows healthy bone around the implant.

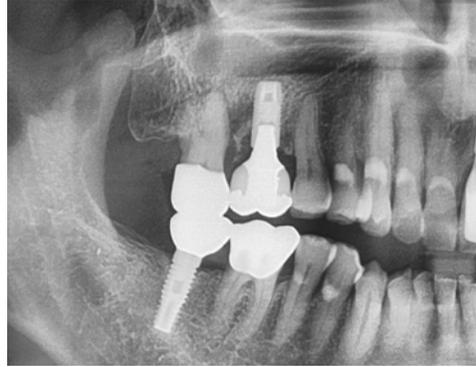
Pre-operative X-ray shows bone loss present around the same implant.

Patient suffered from a peri-implantitis with bone loss occurring all around the implant. The condition was to be treated with implantoplasty and bone grafting to fill in the gap.

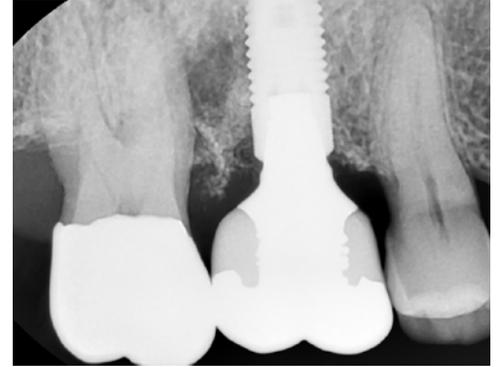
Pre-operative X-ray, close-up.

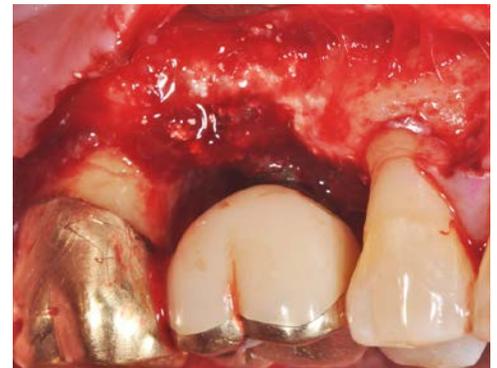
Bone defect, buccal side.

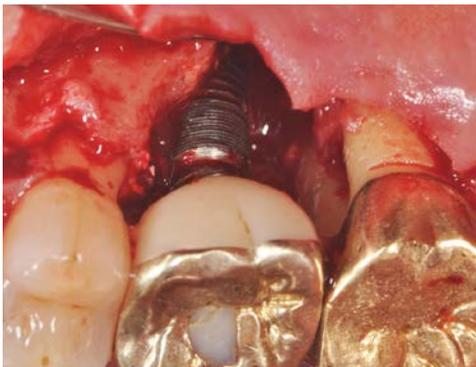
Bone defect, lingual side.

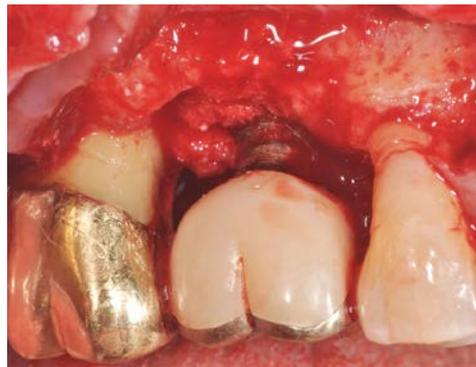
InterOss® Collagen placement, buccal side.

After an implantoplasty was performed, the surrounding gap was filled with InterOss® Collagen which has been trimmed to accommodate the shape of the cavity. Over time, X-rays revealed new bone formation around the implant along with a naturally regenerating gum line.

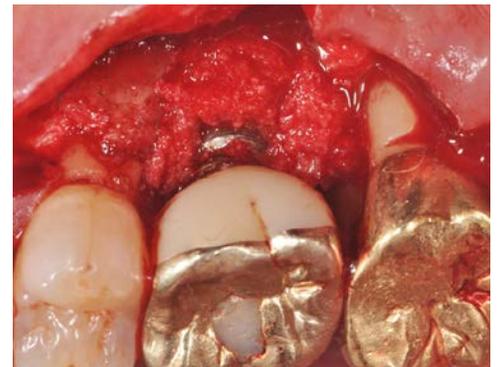
InterOss® Collagen placement, lingual side.

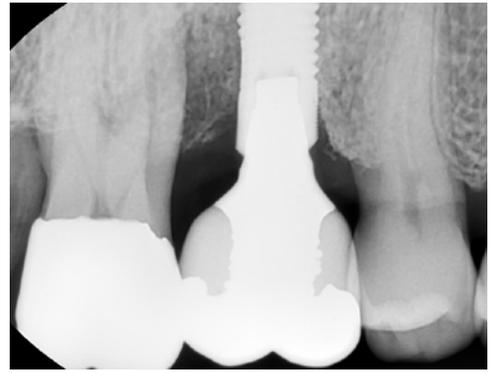
Post-operative X-ray at 1 month.

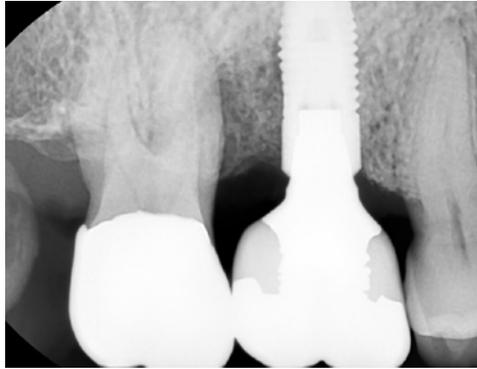
Post-operative X-ray at 4 months.
