Alveolar ridge augmentation due to peri-implantitis

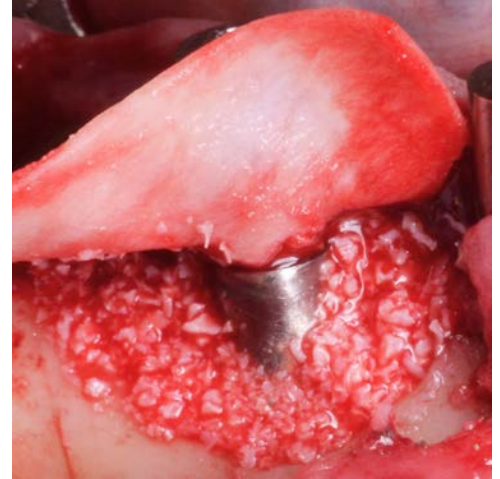
Placement of the InterOss® and autogenous bone mixture.

After an implantoplasty was performed, the receding bone around the implant was filled with a mixture of InterOss® and autogenous bone. X-ray at 10 months shows new bone now surrounding the implant.
