Implant removal due to peri-implantitis with simultaneous ridge augmentation

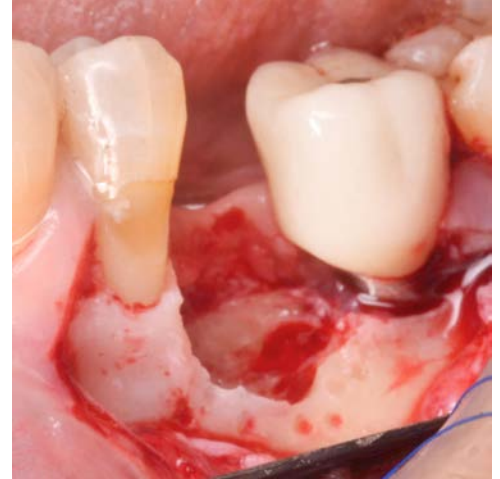
Post-extraction view.
