Alveolar ridge augmentation due to peri-implantitis

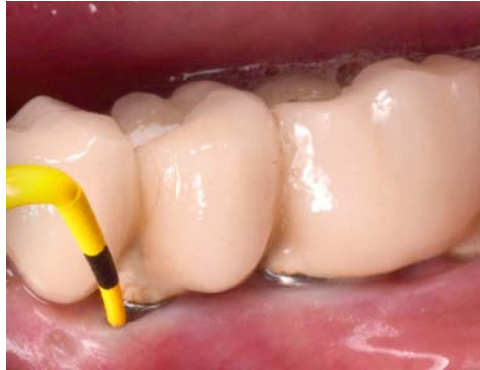
A periodontal probe shows the depth of the defect.

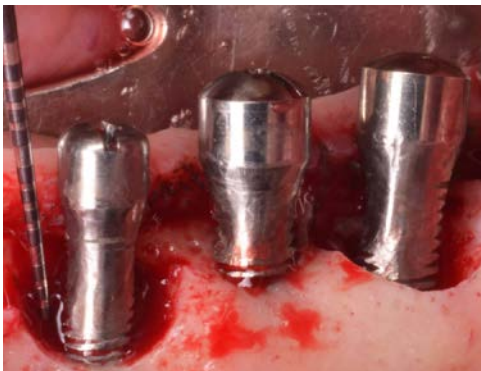
Post-implantoplasty view.

After an implantoplasty was performed, the receding bone around the implant was filled with a mixture of InterOss® and autogenous bone. X-ray at 12 months shows new bone now surrounding the implant.

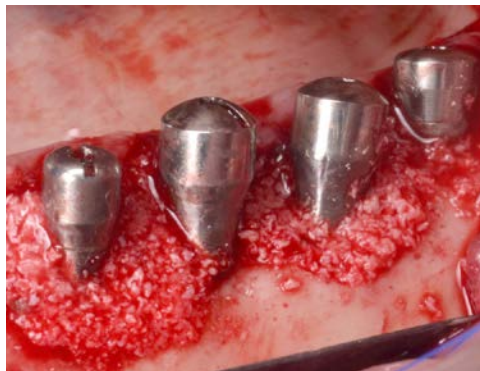
Placement of the InterOss® and autogenous bone mixture.

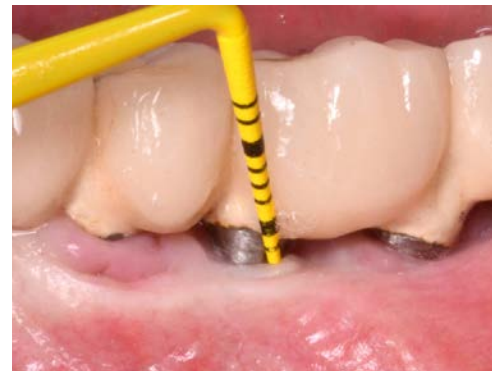
Post-operative view at 12 months.
