# Implant placement in a deficient alveolar ridge in the anterior maxilla

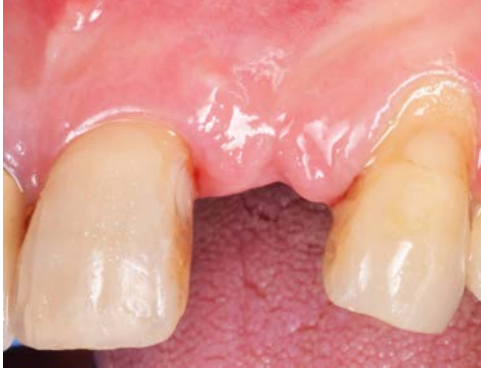
Pre-operative view.

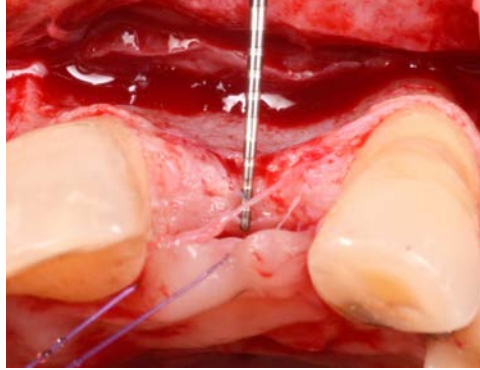
A view of the bone defect.

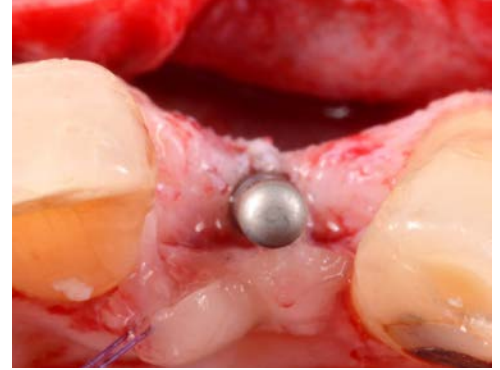
An osteotomy to prepare for implant placement.

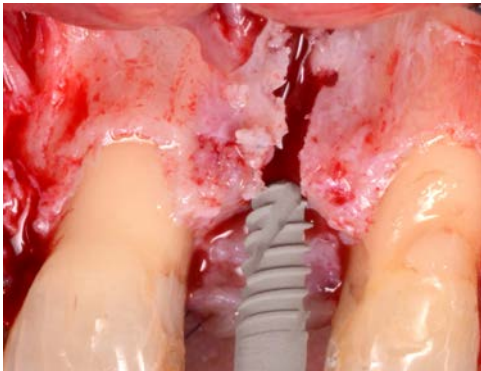
Implant placement.

After the implant is installed, InterOss® is placed in the gap of the bone defect and then wrapped with a collagen membrane. Follow-up at 1 year reveals a still solid bone surrounding the implant.

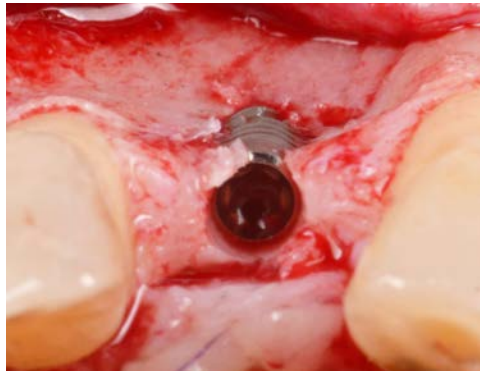
Post-loading view (note the bone deficiency).

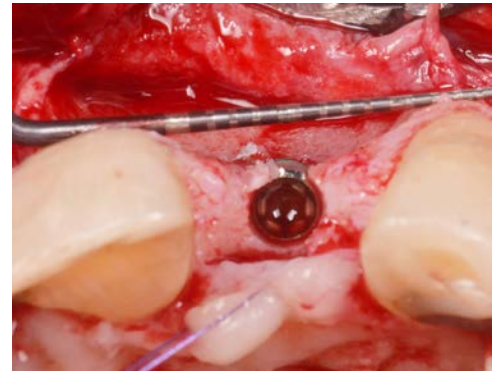
A periodontal probe shows the lack of thickness.

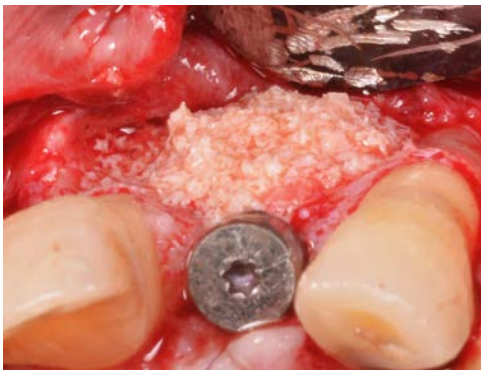
InterOss® placement.

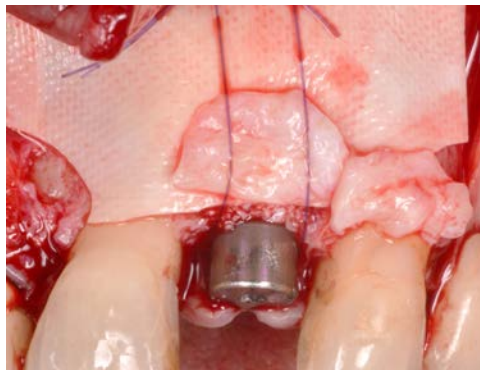
Membrane placement.

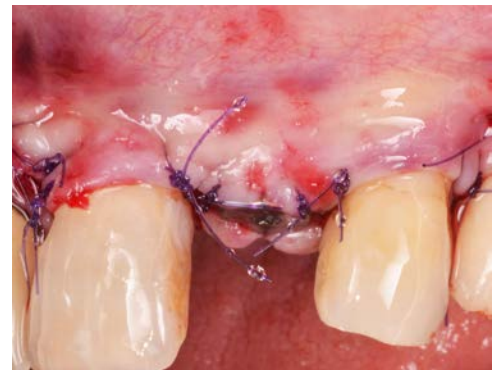
Post-surgical view.

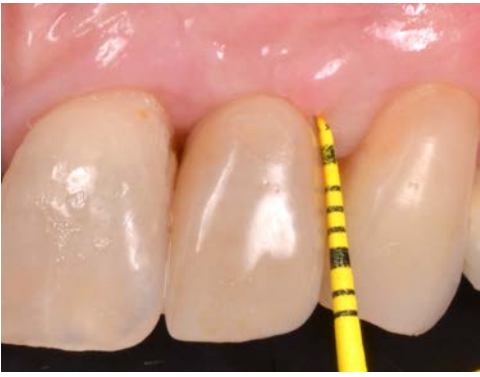
Post-operative view at 1 year.

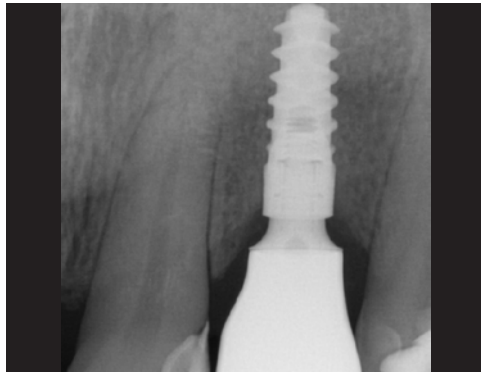
Post-operative X-ray at 1 year.
