Tooth socket preservation and replacement of a failing implant

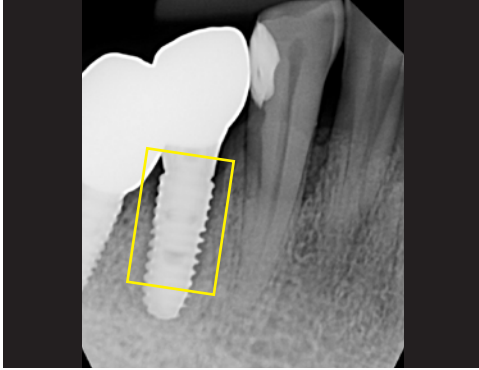
Mobility was detected with one of the patient's existing implants, signifying the beginning of bone loss. The condition was to be treated with extraction of the affected implant, bone grafting, and implant reinstallation.

Pre-operative X-ray.

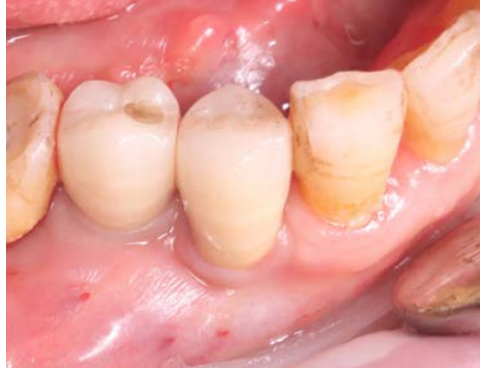
Pre-operative view.

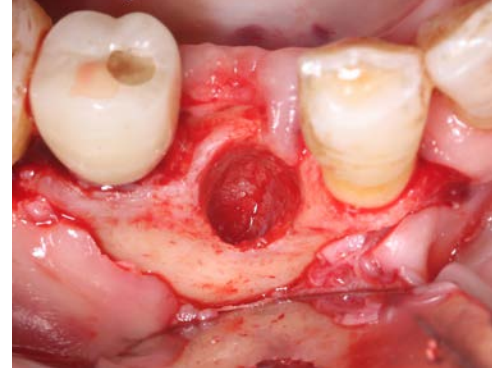
Post-degranulation view.

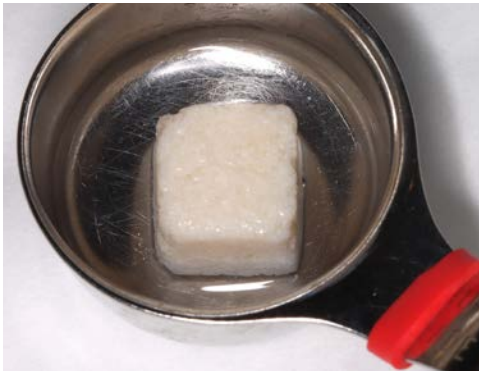
InterOss® Collagen hydrated with saline water.

The socket left by the extracted implant was packed with a hydrated block of InterOss® Collagen then wrapped with a collagen membrane. Re-entry at 9 months reveals the cavity has been fully regenerated, enabling a secure installation of the new implant.

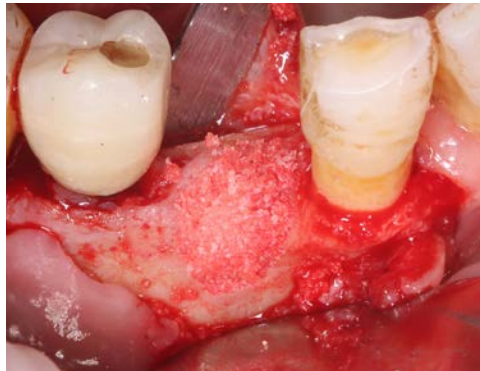
InterOss® Collagen placement.

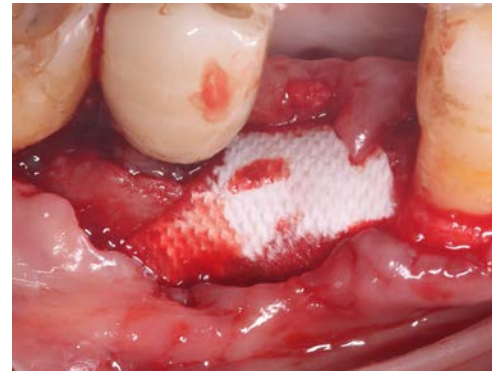
Collagen membrane placement.

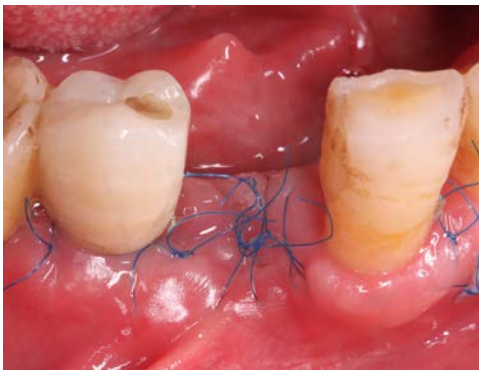
Post-surgical view.

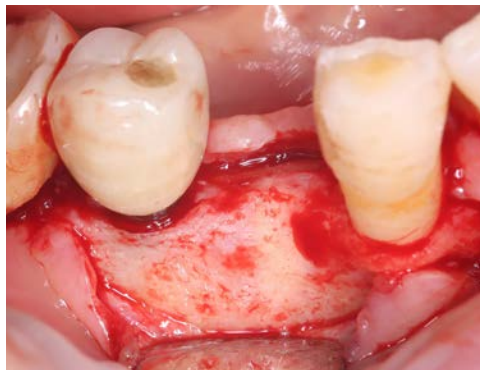
Re-entry view at 9 months.

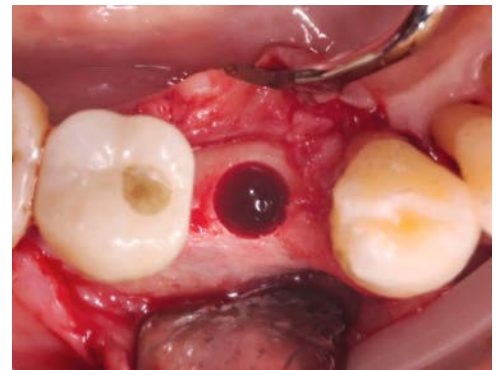
An osteotomy to prepare for implant placement.

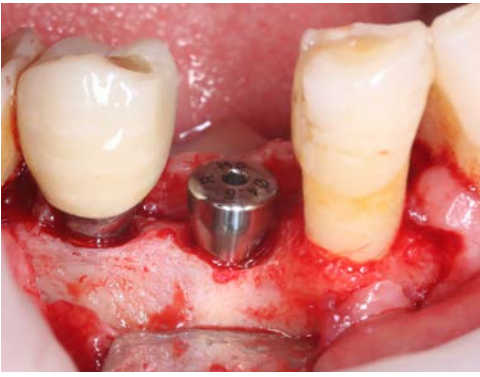
Implant and healing abutment placements.

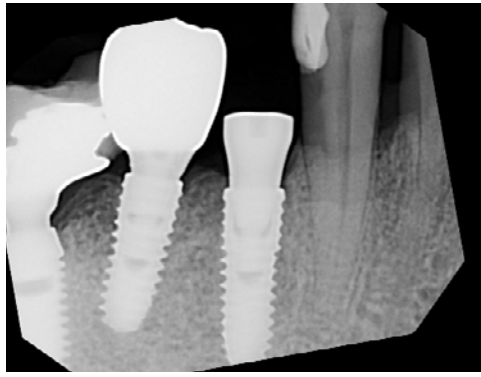
Post-implant X-ray.

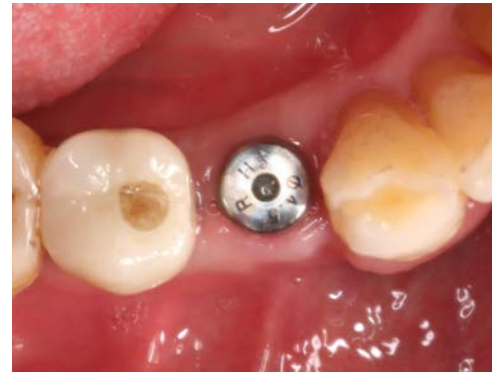
Post-implant follow-up at 4 weeks.
