Ridge augmentation and implant placement via crestal sinus lift

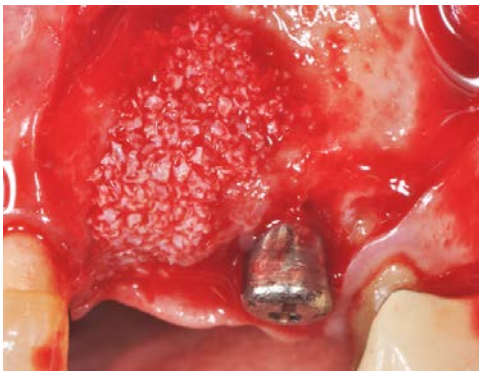
InterOss® placement.

An implant was placed immediately after the sinus lift, using InterOss®, to replace the missing tooth, and the socket left by the fractured root was filled with InterOss® before wrapped with InterCollagen® Guide. Re-entry at 6 months showed newly formed bone, allowing for the additional implant.

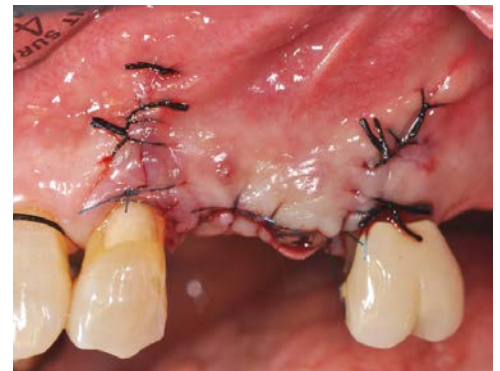
Post-surgical view.

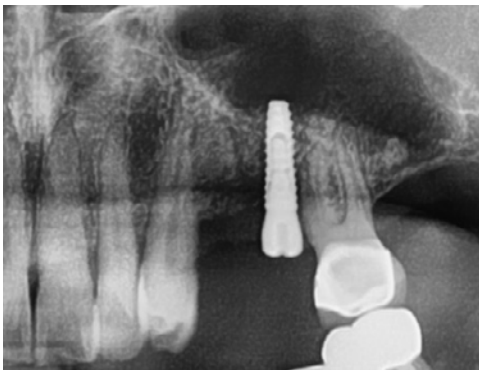
Pre-implant X-ray at 6 months.

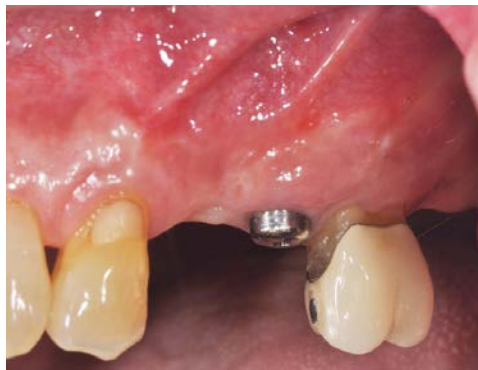
Pre-implant view at 6 months.

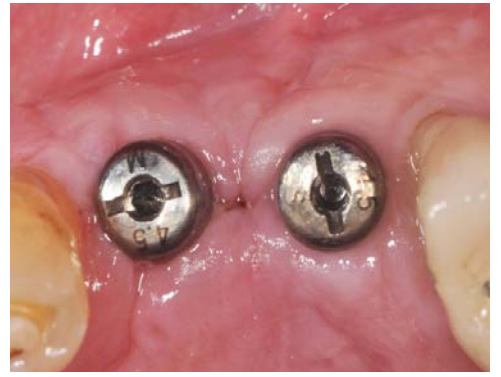
Post-operative at 1 week.
