# Guided bone regeneration of a Type-II socket due to root fracture

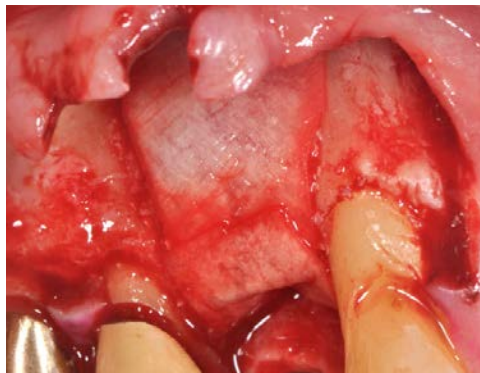
InterCollagen® Guide placement.

Two months after the tooth extraction, the socket was filled with InterOss® and then wrapped with InterCollagen® Guide. Re-entry at 9 months revealed a healthy-looking ridge suitable for an implant installation.

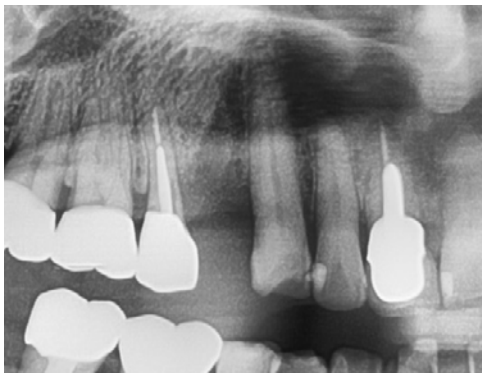
Post-GBR follow-up X-ray at 5 months.

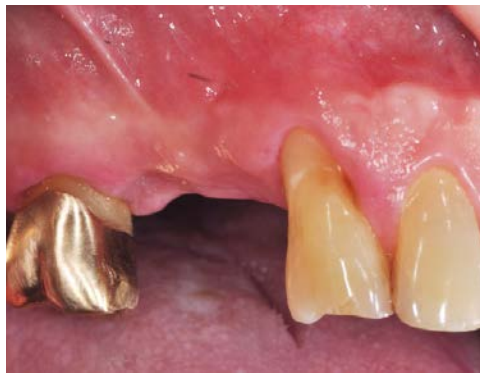
Pre-implant view at 9 months (tooth behind was also extracted).
