Implant removal due to peri-implantitis with simultaneous ridge augmentation

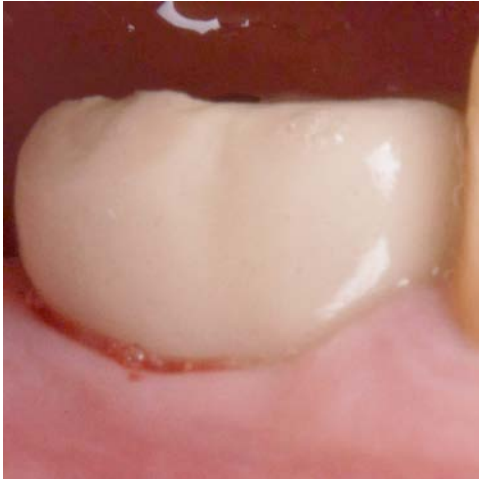
Pre-operative view (note the pus discharge).

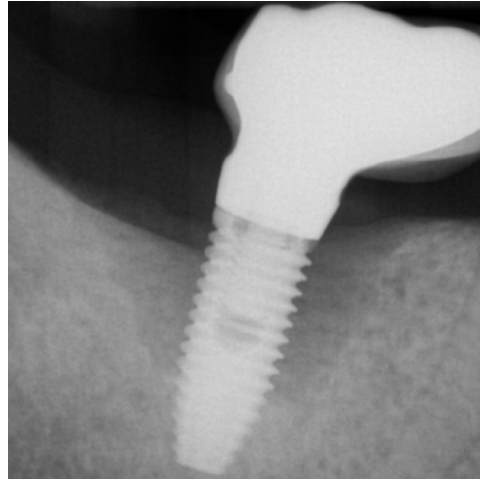
Pre-operative X-ray.

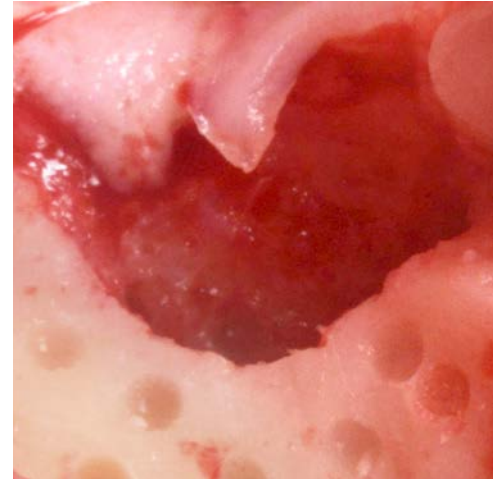
Post-extraction view.

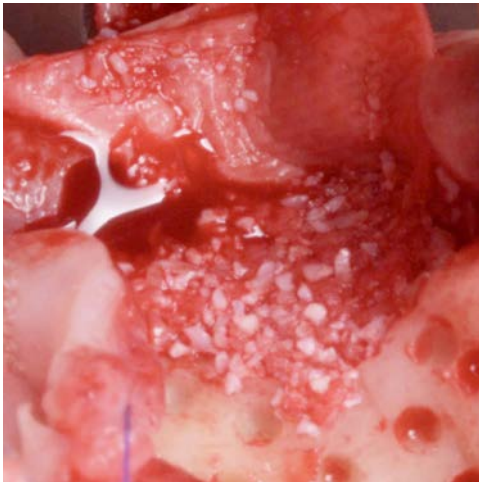
Placement of the InterOss® and autogenous bone mixture.

After the implant was extracted, the defect was filled with a mixture of InterOss® and autogenous bone. At re-entry, the cavity has been completely regenerated, enabling a new implant placement with a lasting stability even after 12 months.

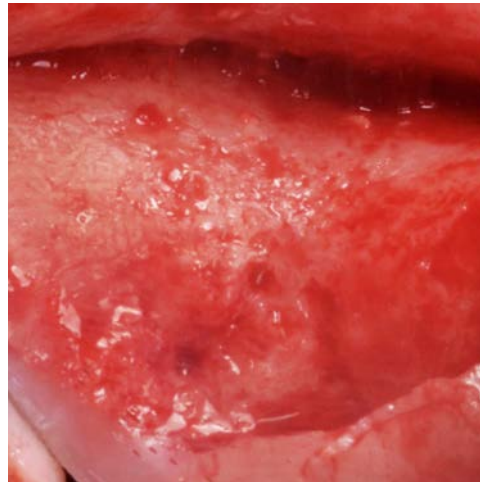
Re-entry view.

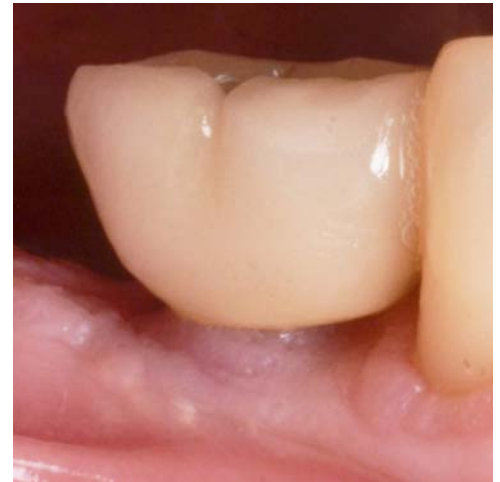
Post-loading view at 12 months.
