Immediate implant placement with simultaneous ridge augmentation

Patient History

Process & Conclusion

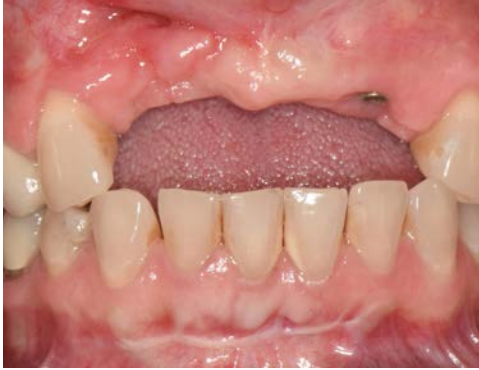
Pre-operative view.

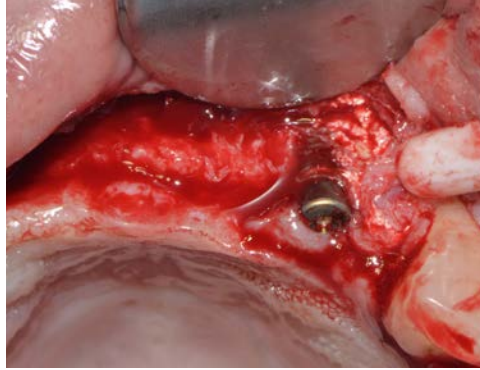
A view of a previously installed implant.

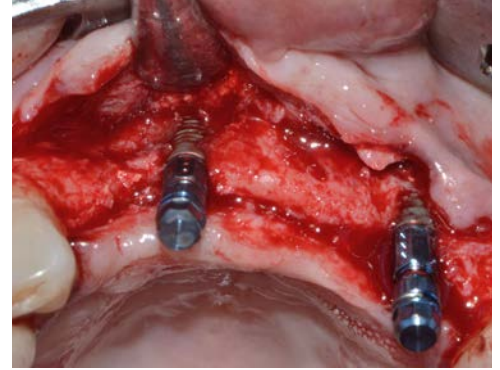
Placement of an additional implant.

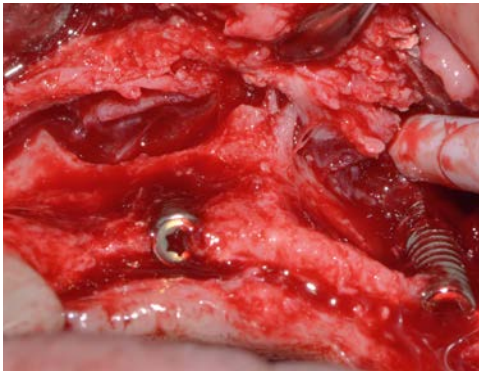
A view of the bone defect.

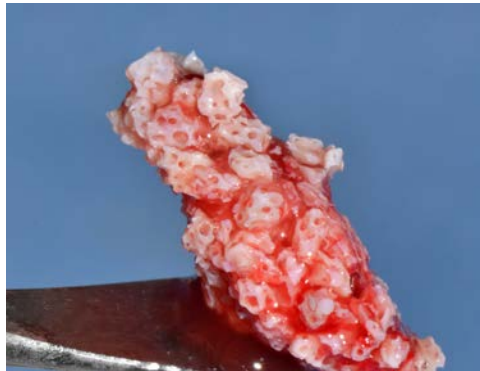
InterOss® granules that have been mixed with the patient's blood.

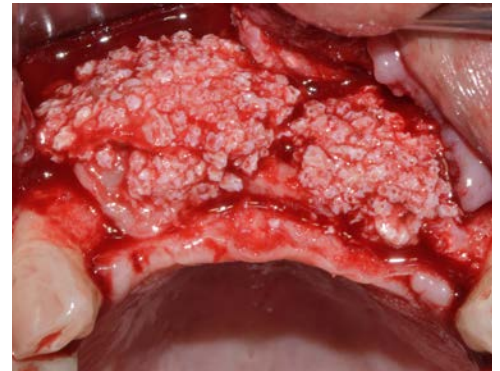
InterOss® placement.

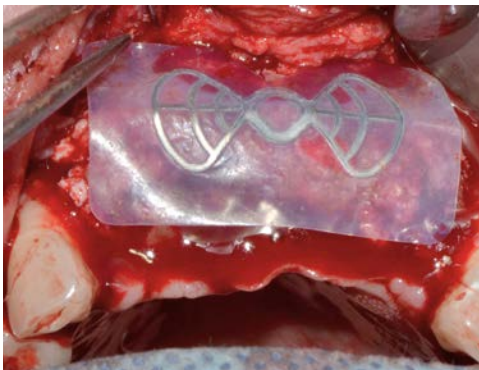
PTFE membrane placement.

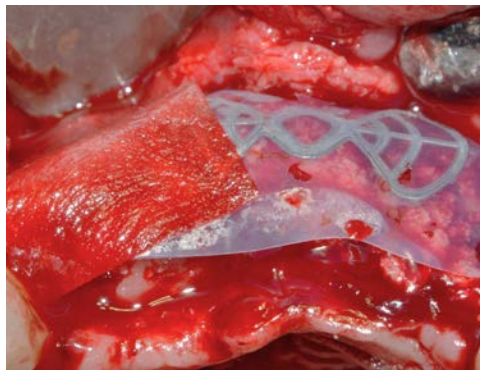
InterCollagen® Guide placement.

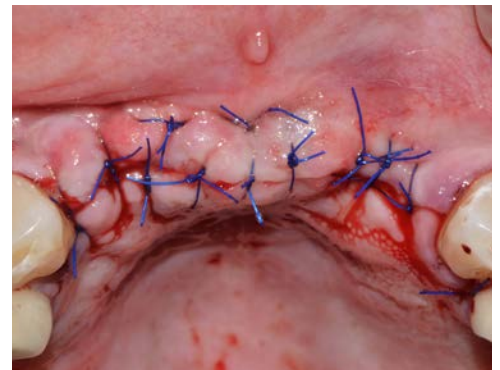
Post-surgical view.

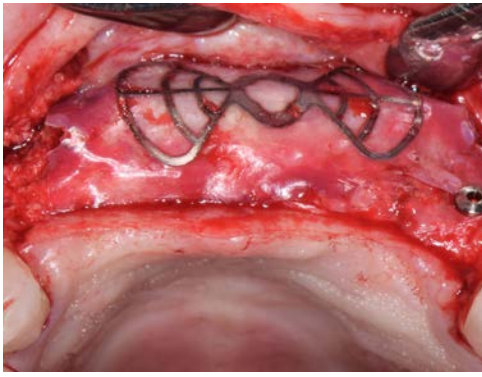
View at re-entry after 5 months; note the absent InterCollagen® Guide.

After an additional implant was installed, the sunken ridge was filled with InterOss® granules and wrapped with InterCollagen® Guide and a PTFE membrane. Re-entry at 5 months revealed a substantial bone gain with a density that's able to securely hold the implants.

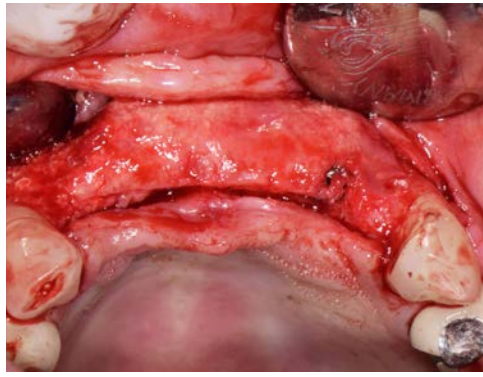
Post-grafting view at 5 months.

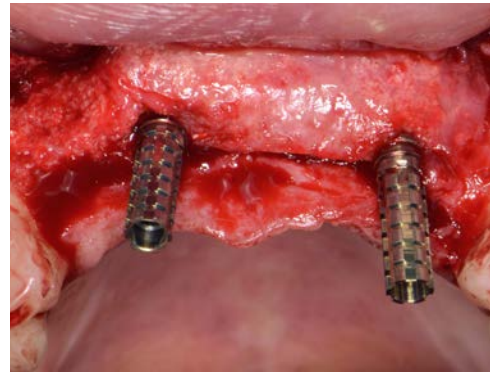
Abutment placement.

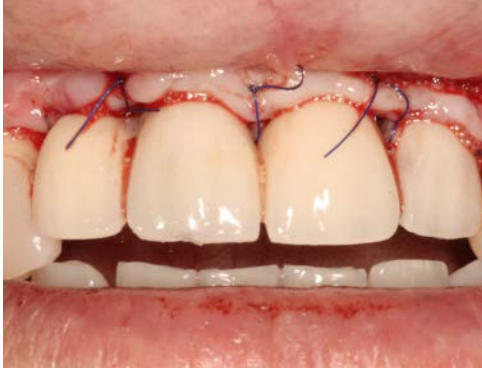
Crown placement.

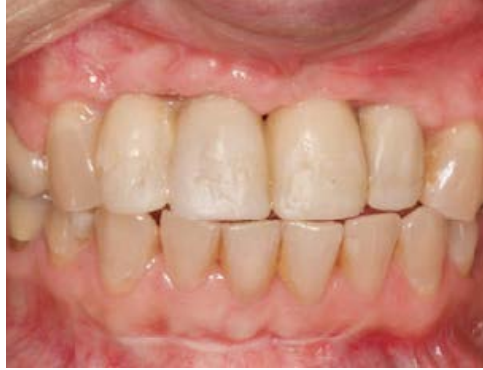
Follow-up view at 3 months.

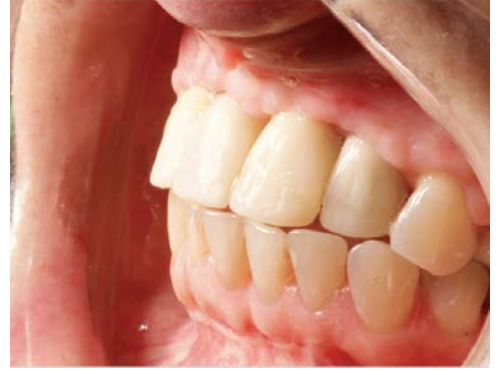
Alternative follow-up view at 3 months.
