Immediate implant placement with simultaneous guided bone regeneration

Patient History

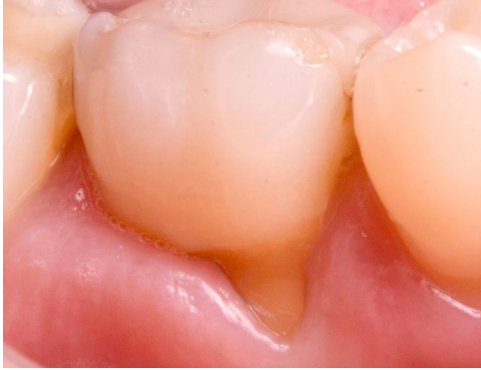
Pre-operative view.

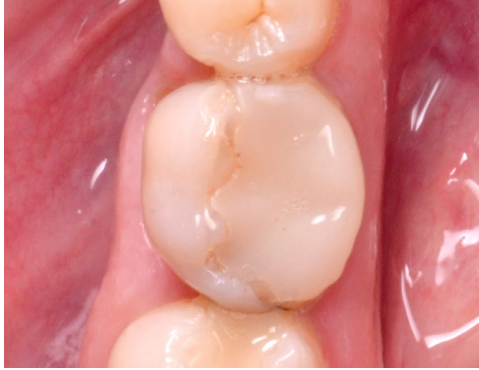
Another pre-operative view.

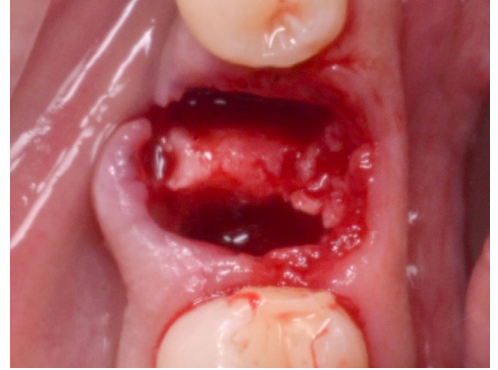
Post-extraction view.

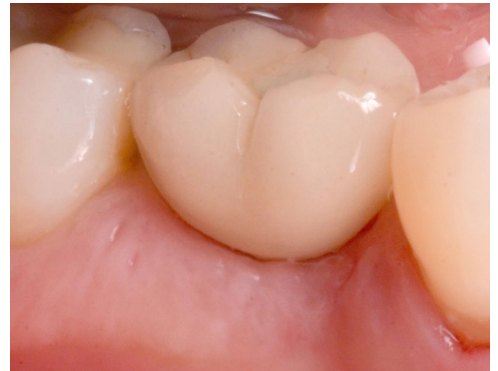
Post-operative view at 1 year.
