# Implant removal due to peri-implantitis with simultaneous ridge augmentation

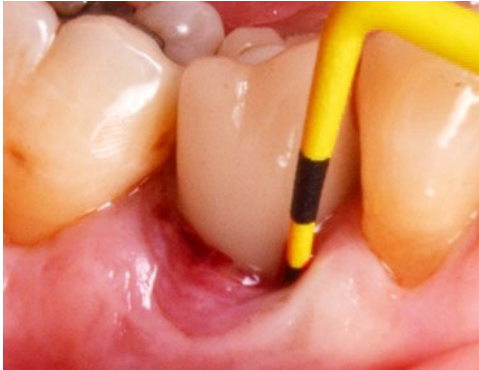
Pre-operative view.

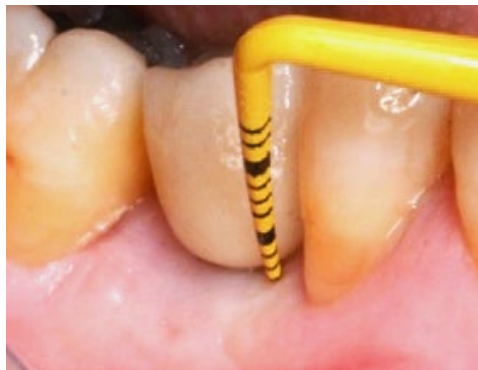
Post-operative view at 1 year.
