InterOss® Mediated GBR Preventing the Maxillary Sinus Augmentation Procedure

Dr. David M. Kim
Boston, MA
United States

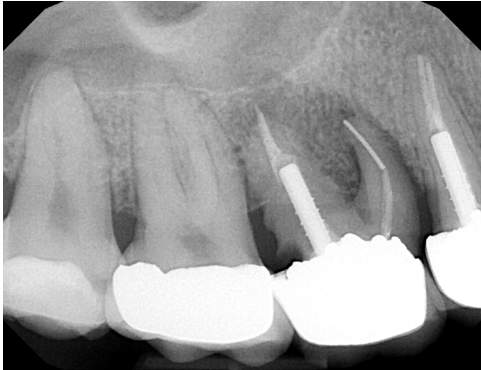
Pre-operative X-ray.

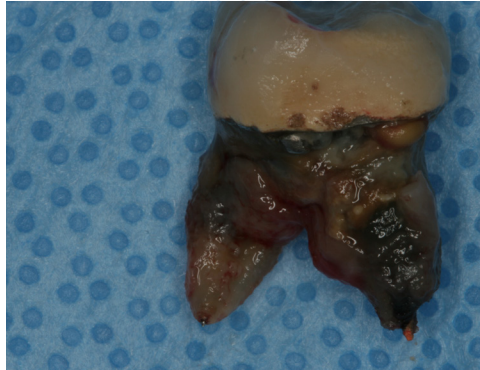
Extracted tooth with recurrent decay, short roots, and infection around the tooth.

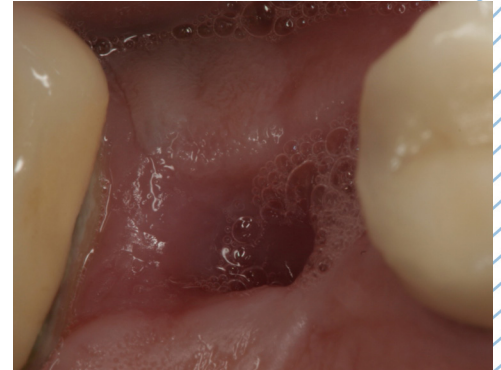
A clinical picture at 6 weeks displaying partial soft tissue healing at the extraction site.

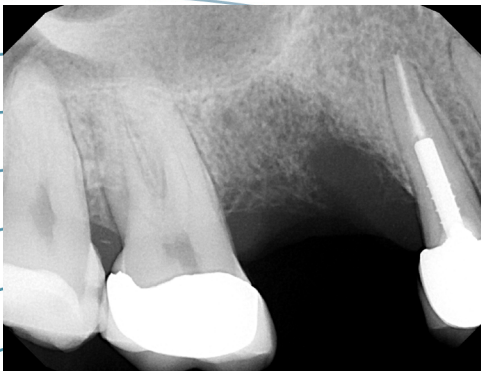
A periapical (PA) radiograph at 6 weeks revealed incomplete socket healing and proximity to the sinus membrane if the crestal bone level is not maintained.

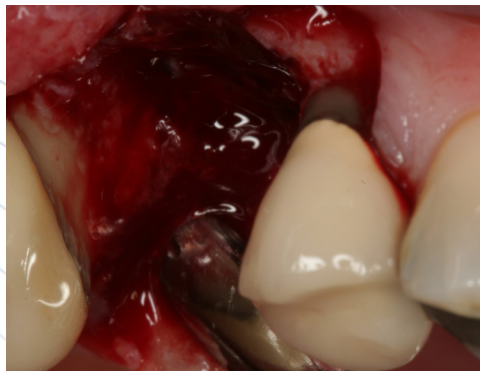
The buccal view of the extraction site revealed significant buccal bone destruction in addition to bone loss on the mesial aspect of the second molar.

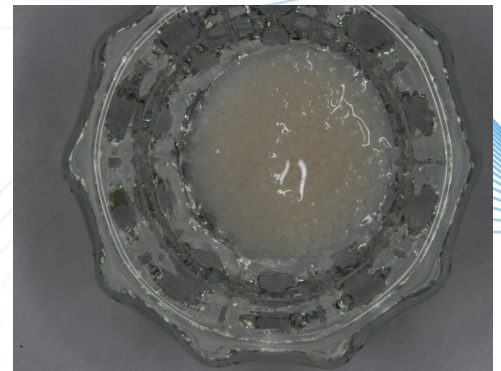
Guided bone regeneration (GBR) procedure was performed with InterOss® anorganic cancellous bone granules (0.25-1.0mm) that have been hydrated with the growth factor (rhPDGF-BB).

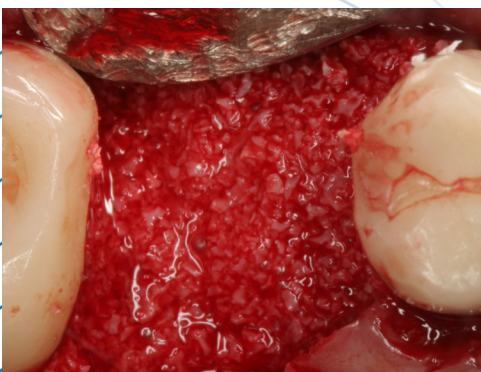
The InterOss® was packed into the extraction socket.

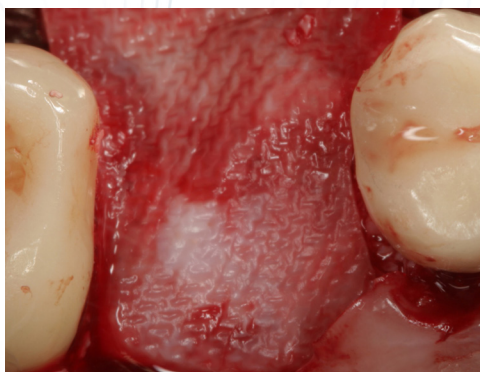
A cross-linked collagen barrier membrane was placed over the bone graft.

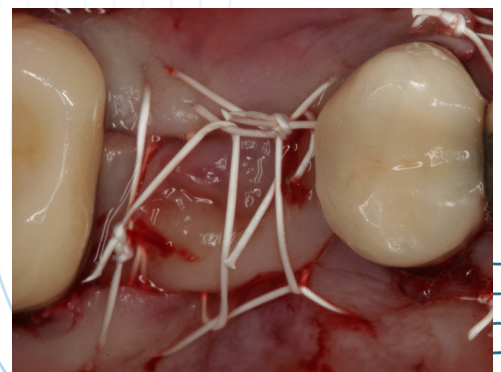
To maintain the vertical bone height, the primary flap closure was obtained.

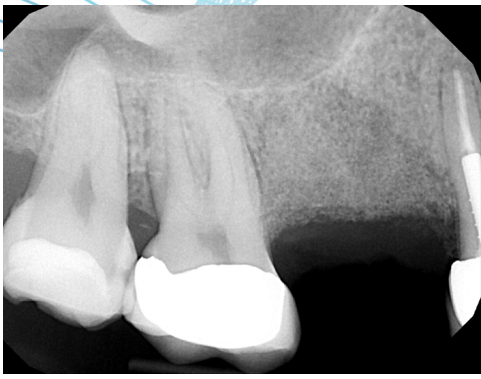
A PA was taken immediately after the GBR.

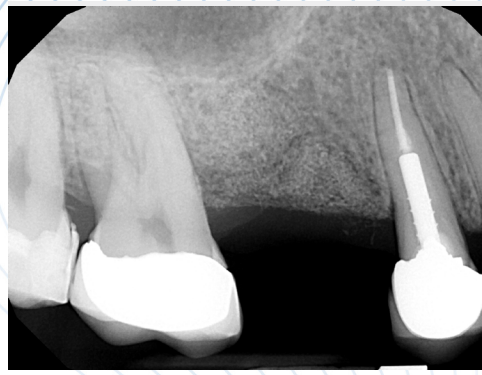
The new PA taken at 6 months revealed the maintenance of augmented vertical bone height.

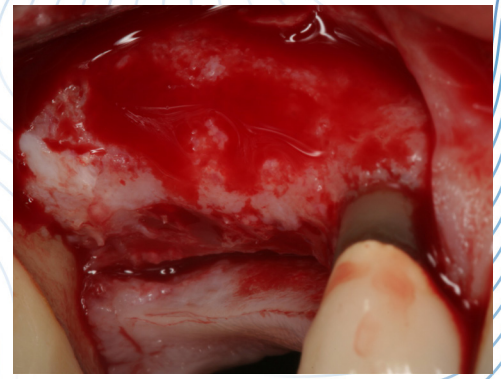
The full-thickness flap was elevated, and the regenerated bone appeared to be vital with a minimal amount of remnant graft particles, and the vertical bone height was restored.

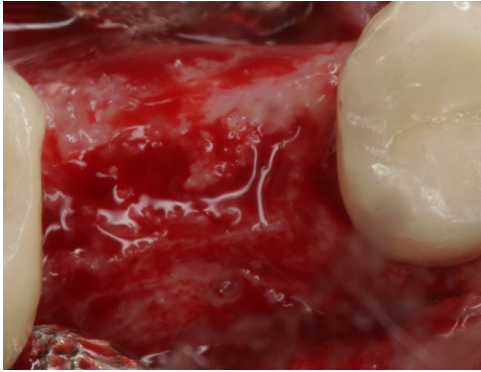
The occlusal view demonstrating the maintenance of the ridge width with InterOss.

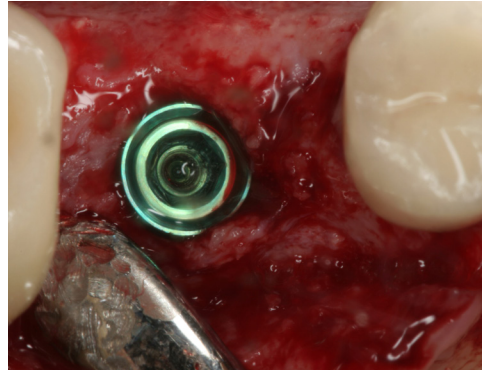
A dental implant was placed into the regenerated bone, achieving good primary stability.

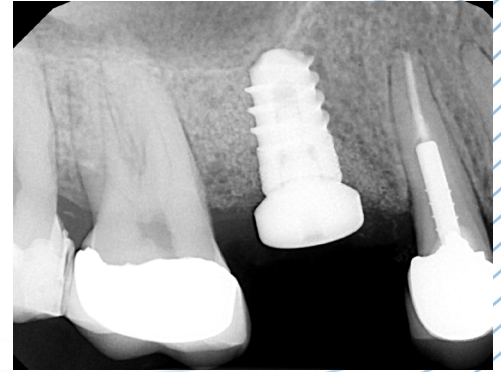
A PA taken immediately after the surgery.

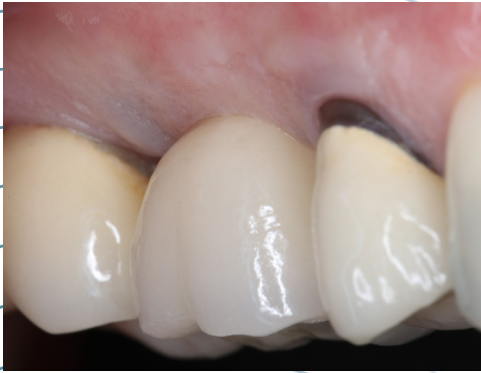
A clinical picture of the restored implant demonstrating good soft tissue support.

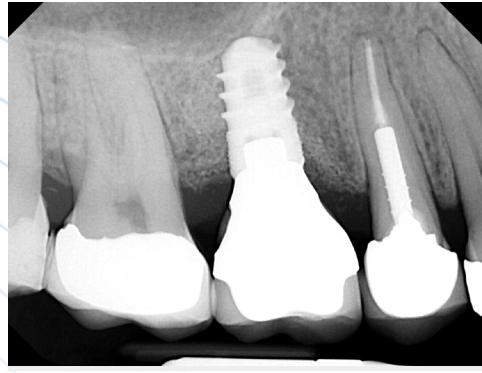
A PA taken after the implant restoration.

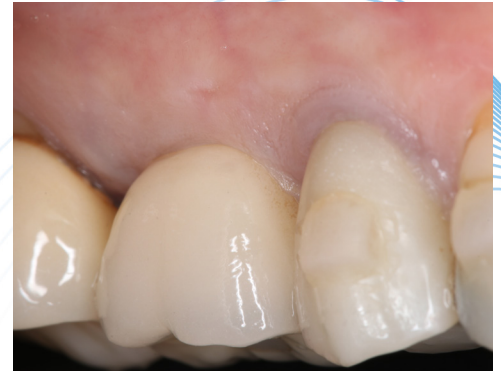
A clinical picture 9 years after the GBR, demonstrating healthy soft tissue support around the implant, while there was a gingival recession on the adjacent natural tooth.

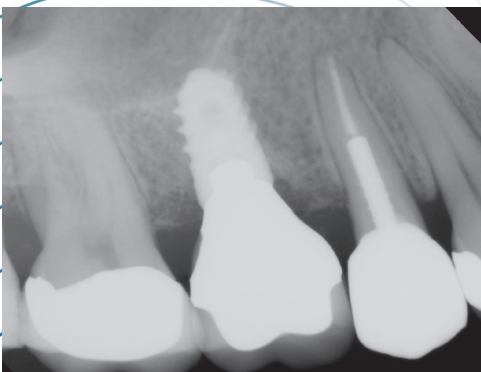
A 9-year post-GBR PA demonstrating a stable long-term maintenance of the supporting bone around the implant.
