# Successful Bone Augmentation with Simultaneous Early Implant Placement

Dr. David M. Kim  
Boston, MA  
United States

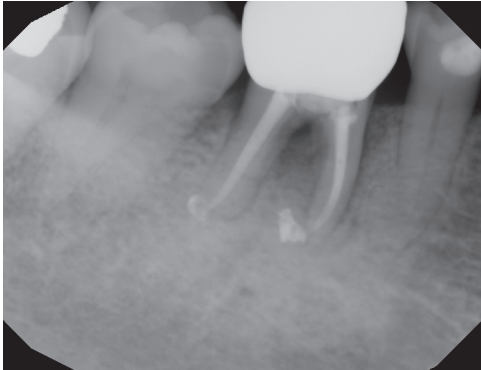
Pre-operative X-ray.

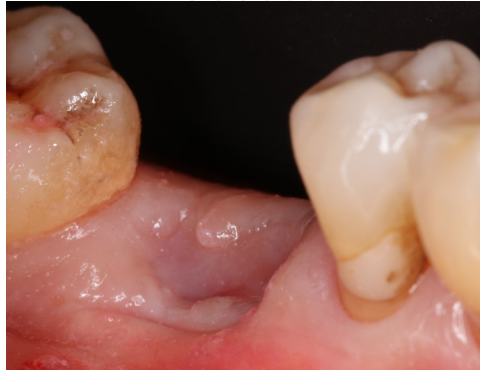
The tooth was extracted, and the extraction socket was allowed to heal for 8 weeks.

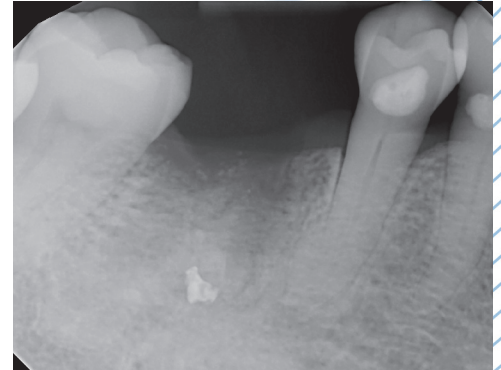
A periapical (PA) radiograph demonstrating inadequate socket healing.

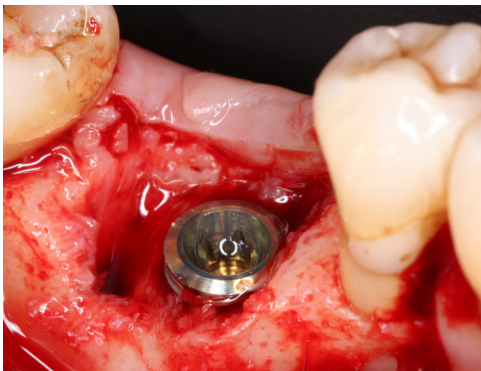
An early implant placement was performed in the socket that had not completely healed.

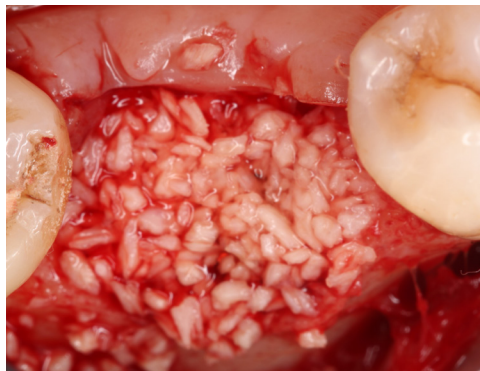
Bone augmentation was performed around the exposed implant threads with SigmaOss® corticocancellous allograft (0.25-1.0mm).

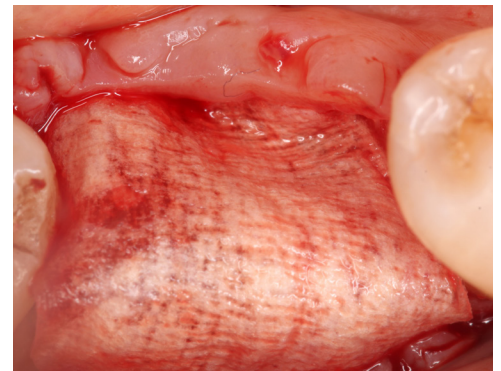
A cross-linked InterCollagen® Guide collagen barrier membrane was placed over the bone graft.

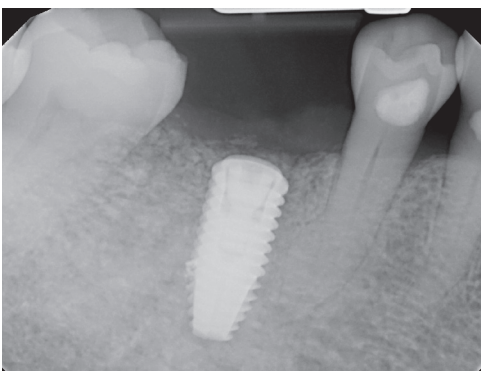
An immediate post-bone grafting PA.

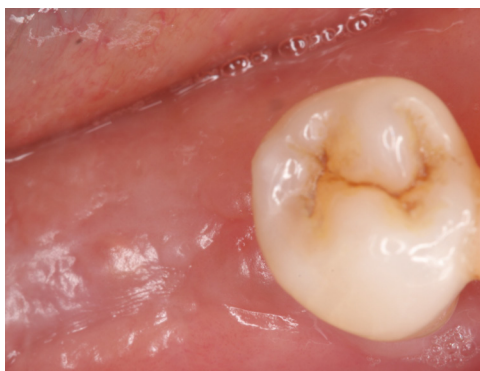
Soft tissue healing 3 months after the bone augmentation.

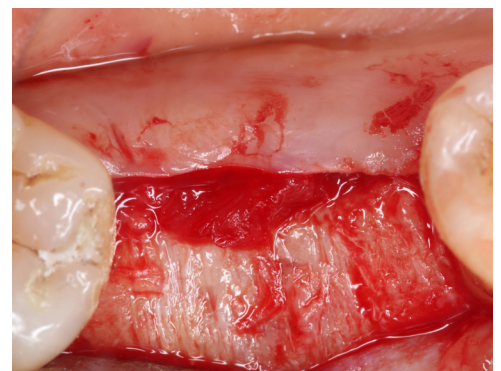
Membrane presence 3 months after the bone augmentation procedure, allowing for protection of the underlying bone graft.

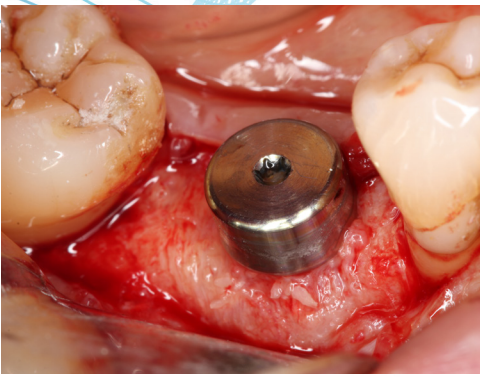
In 3 months, only a small amount of remaining allograft was noticed around the implant, and the bone grafting was successful.

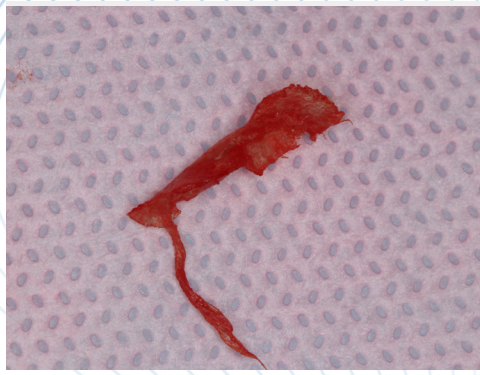
Picture of a remnant InterCollagen® Guide collagen barrier membrane.

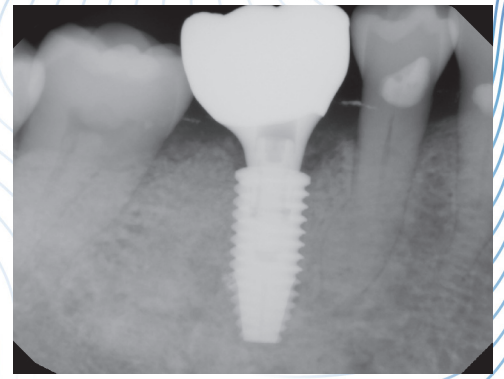
A PA demonstrating radiographic evidence of an osseointegrated dental implant.

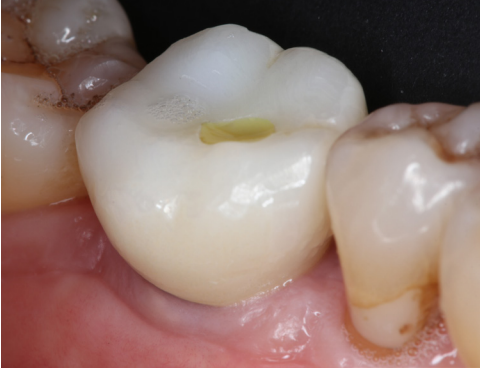
A clinical picture after the implant restoration, demonstrating good soft tissue support around the implant crown.
