# Immediate Implant Placement with InterOss® Bone Grafting in the Posterior Maxilla

Dr. Ekaterina Zernitckaia  
Loma Linda University School of Dentistry  
Department of Implant Dentistry  
Loma Linda, California, USA

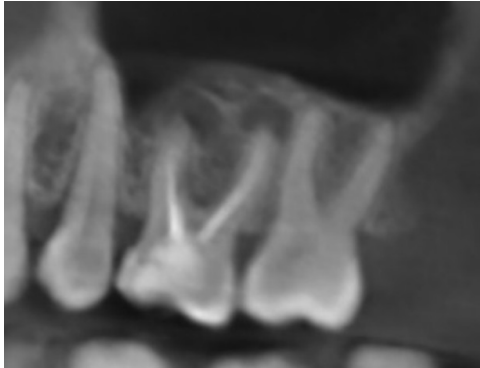
Preoperative radiographic view.

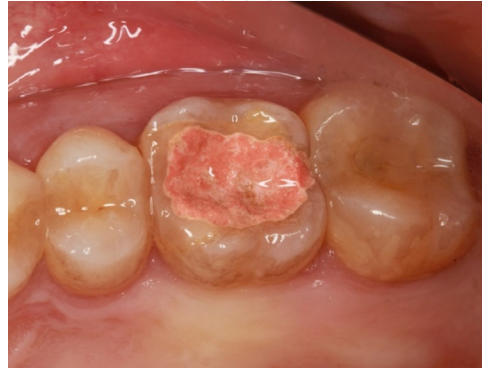
Preoperative intraoral view.

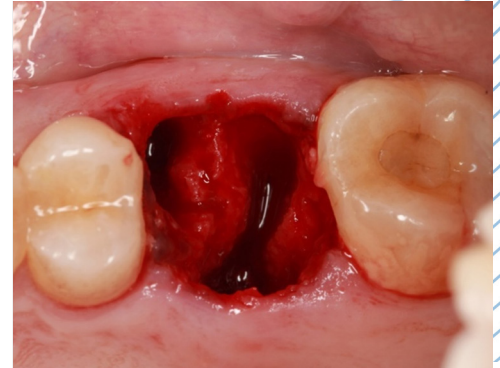
Post-extraction socket demonstrating preservation of the septum.

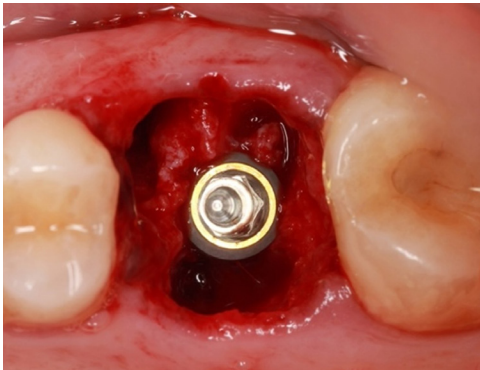
Implant placement.

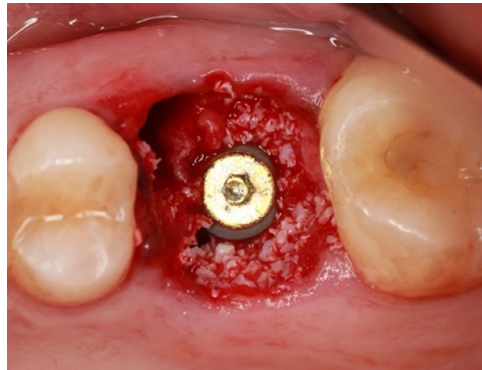
InterOss® placement.

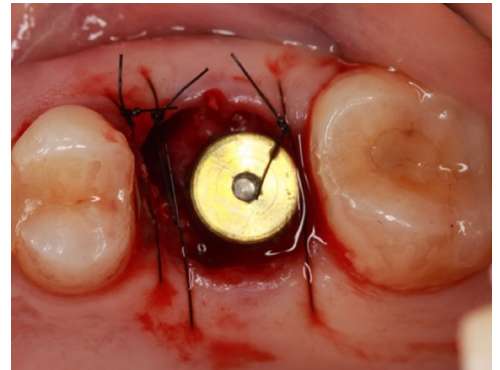
Placement of healing abutment and suturing.

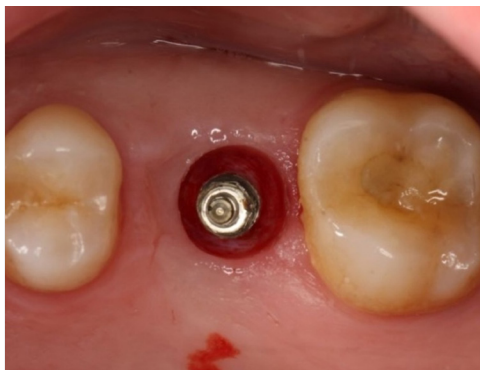
Soft tissue contour at 3 months postoperatively, showing adequate volume and healing.

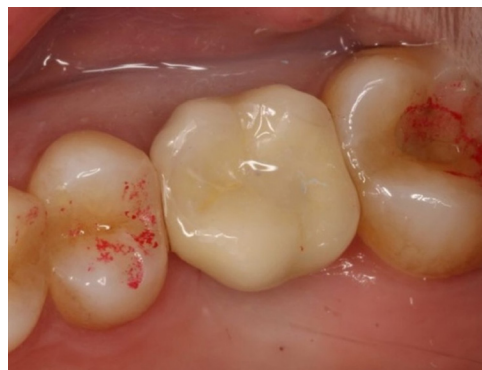
Final prosthetic restoration.

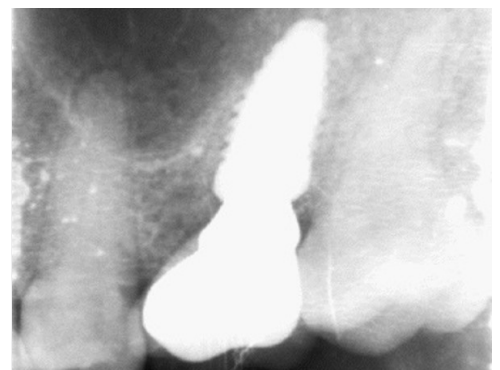
Rg control immediately after crown placement.

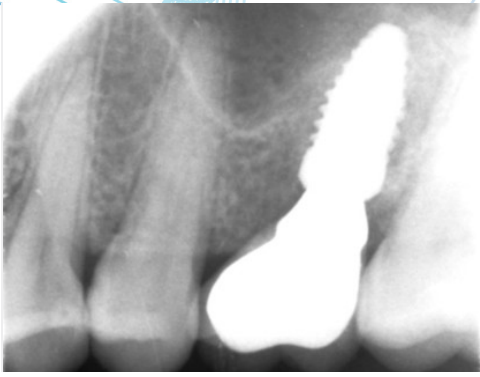
Rg control at 4-years follow-up.

Clinical and radiographic follow-up demonstrated stable peri-implant conditions and successful integration of the implant-supported restoration.

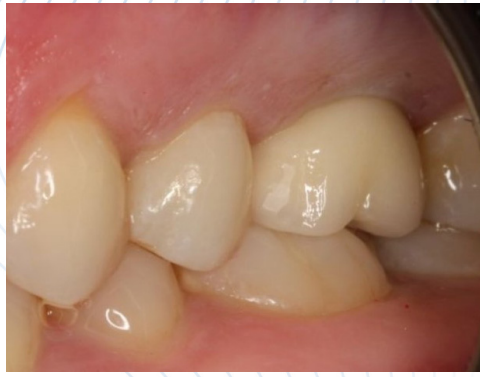
Intraoral view at 4-years follow-up.
