Horizontal ridge augmentation with guided bone regeneration

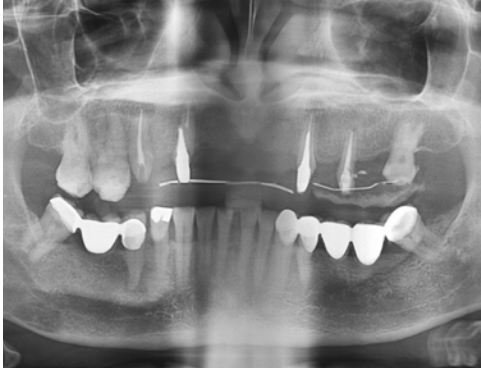
Pre-operative X-ray.

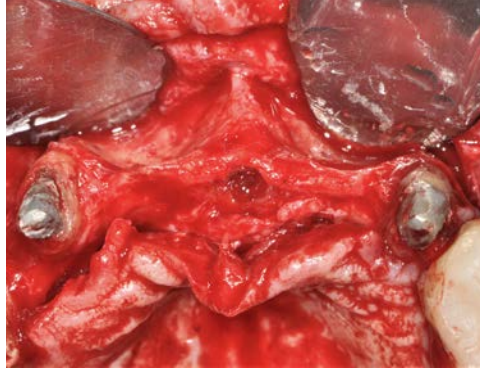
A view of the bone defect.

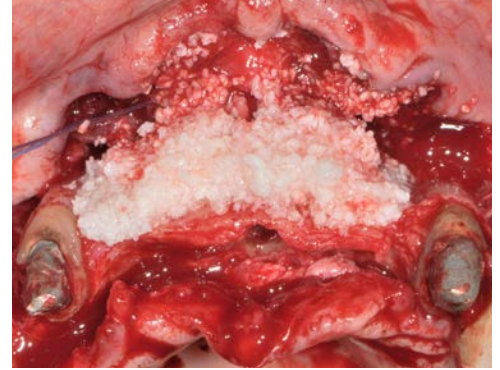
InterOss® placement.

The sunken ridge was filled with InterOss® granules which were then wrapped with collagen membranes. Re-entry at 8 months shows newly regenerated bone at the defect site as thick as 7 mm.

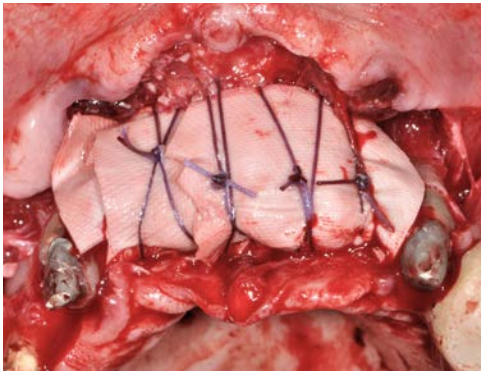
Membrane placement.

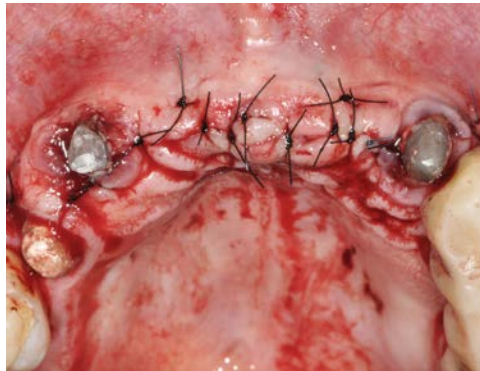
Post-surgical view.

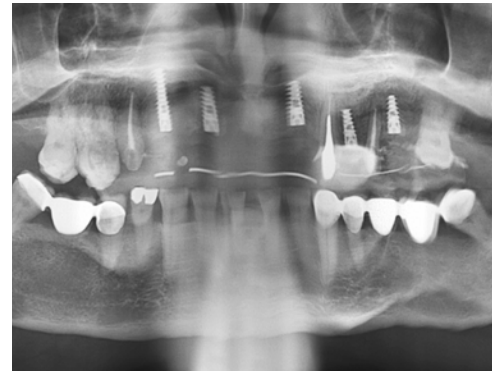
Post-operative X-ray at 8 months

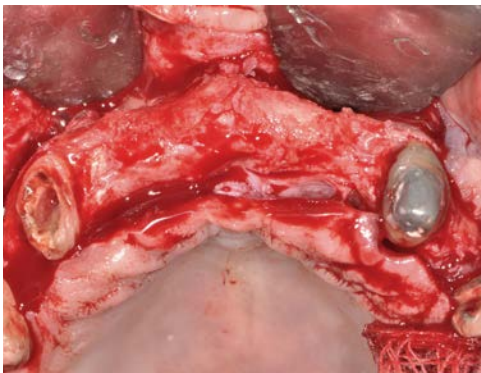
Post-operative view at 8 months.

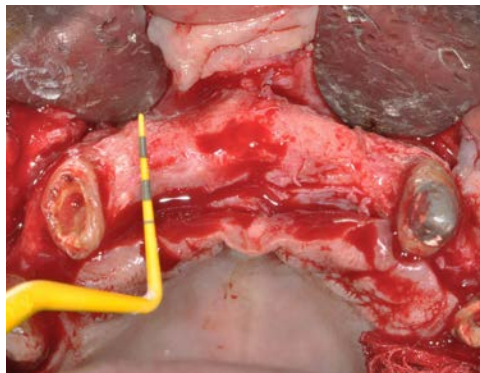
New bone was measured at 7 mm in thickness.
