Implant placement and simultaneous crestal sinus lift

Patient History

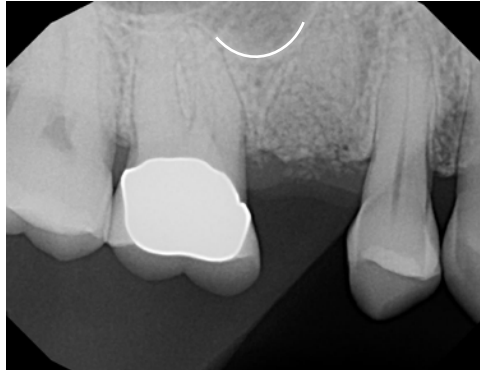
Pre-operative X-ray.

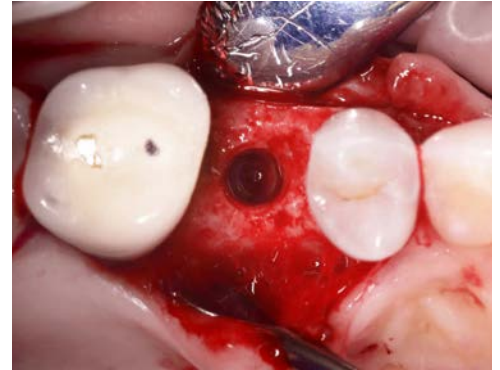
An osteotomy to prepare for implant placement.

After a careful osteotomy, InterOss® granules were grafted through the opening prior to implant installation. Follow-up X-ray at 3 months shows the maintained thickness of the grafted bone and, at 8 months, a highly observable formation of new cortical bone with increased height.

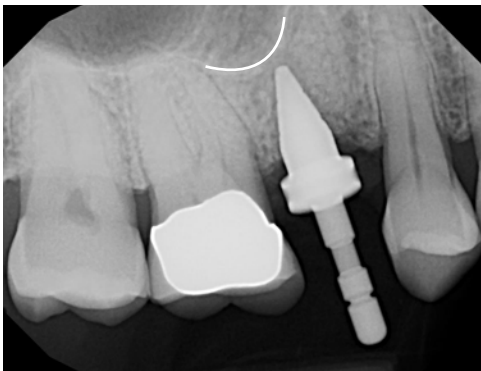
Intra-osteotomy X-ray.

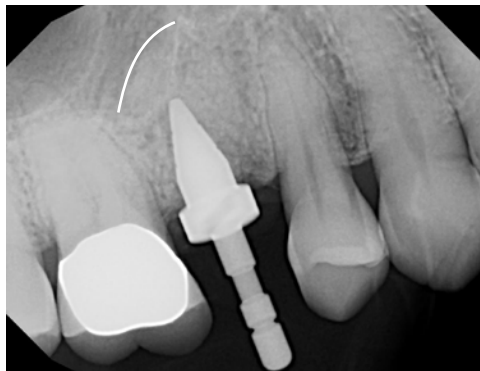
X-ray shows InterOss® placement.

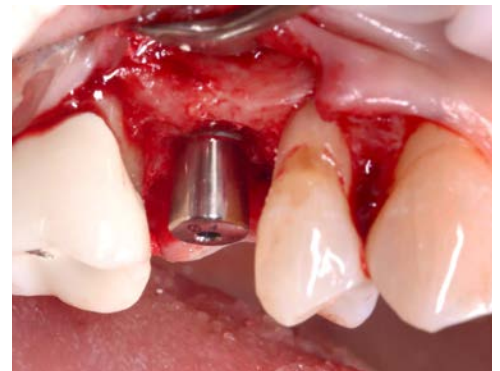
Implant placement and healing abutment connection.

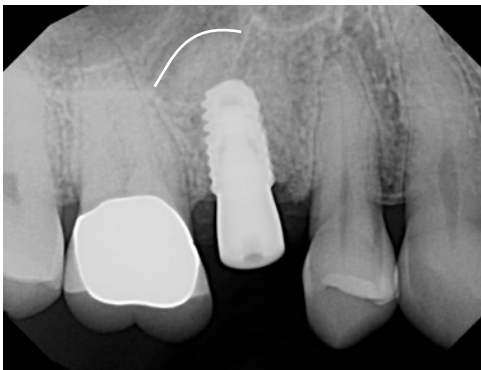
Post-surgical X-ray.

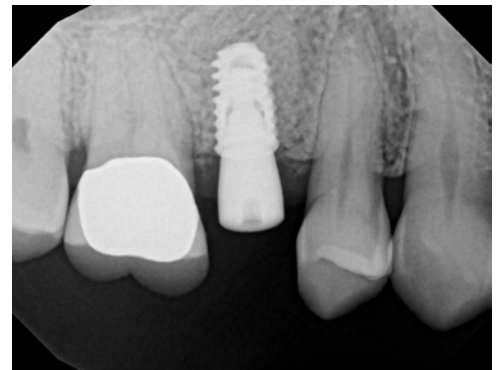
Post-loading X-ray at 3 months.

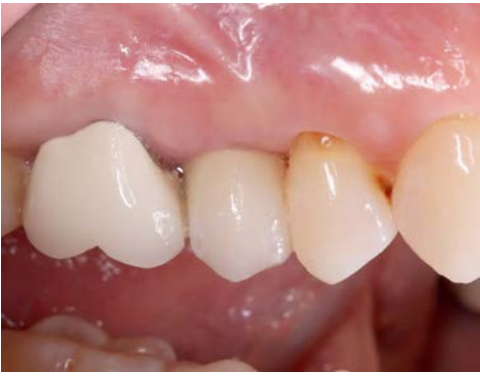
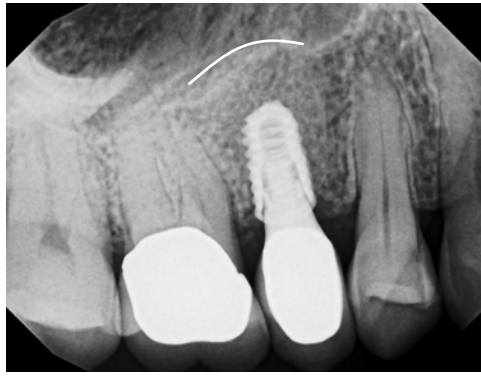
Post-operative at 8 months and crown placement. Post-operative X-ray at 8 months.
